HOME INSPECTION REPORT

2 Redcar Ave Unit 4

Toronto

Inspection Date: June 6 2019

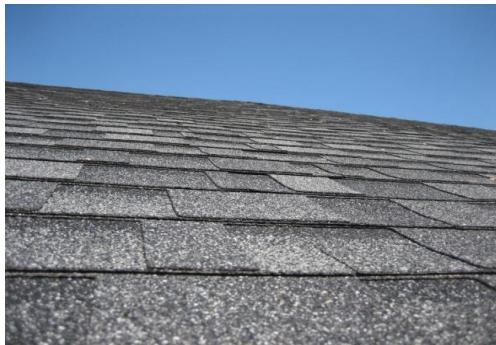
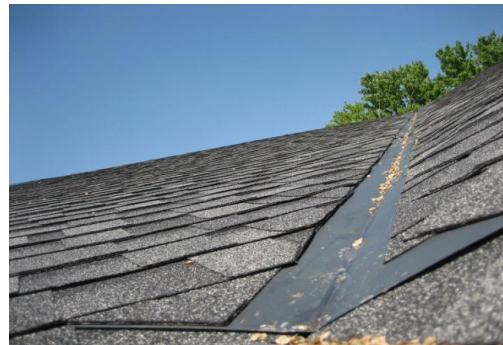
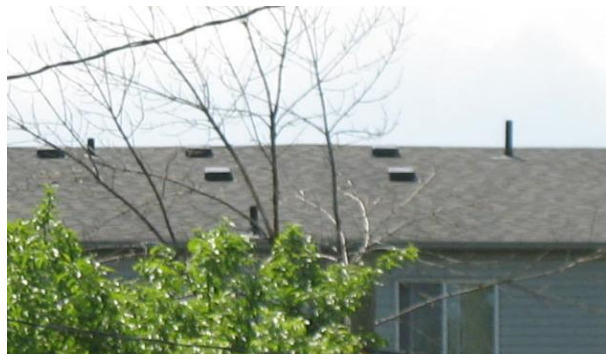
Sloped Surface: [high quality shingles in good repair](#)

[Note: Recommend Annual Maintenance Contract for Roof Surface, Flashing Details and Chimney\(s\)](#)

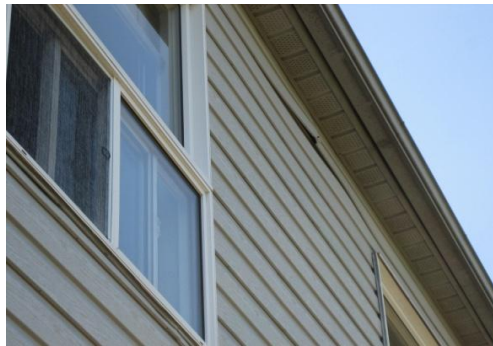
DOORS/WINDOWS: overall in good repair - some screen repairs

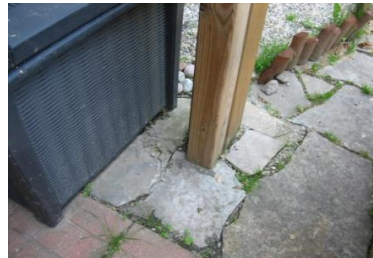
DECK original columns are rotted at base and have been reinforced however require proper footing - repair for safety and better stability

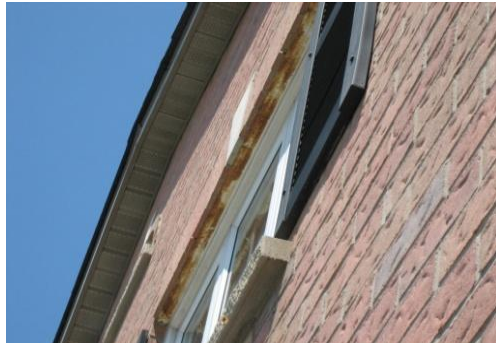
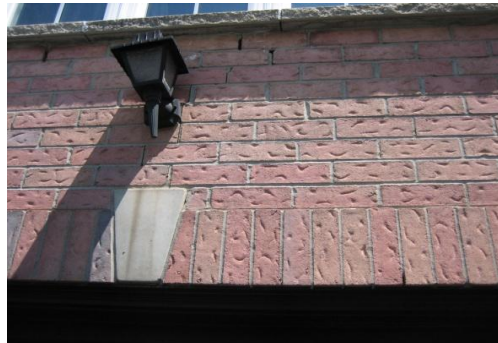
WALLS: front: paint metal lintel, minor crack above garage door

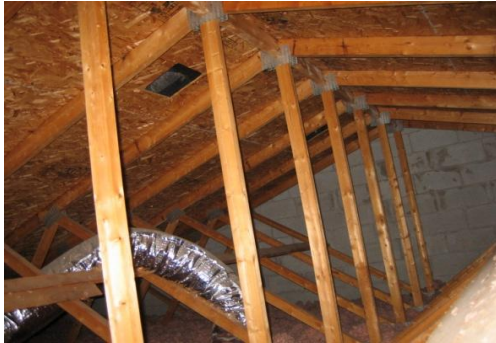
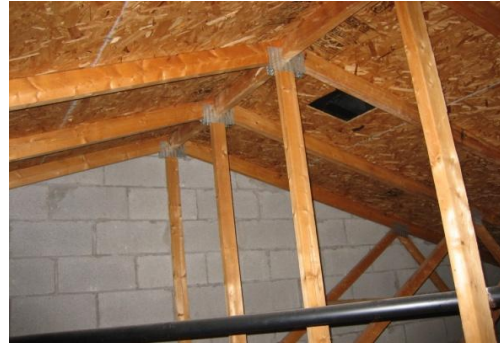
ROOF: overall in good repair

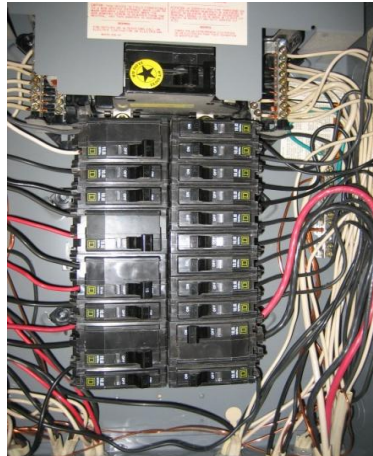
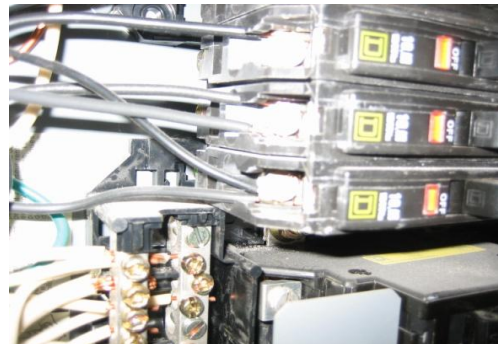
SERVICE PANEL: **crowded, double taps, install sub-panel if required overall in good repair**

Note 1: All recommendations are safety issues - Treat them as high priority.

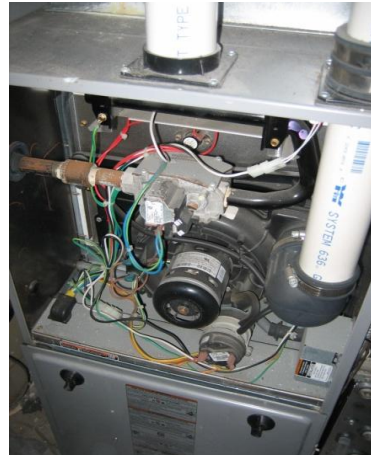
Electronic Filter: [old, recommend disconnecting and installing disposable filter inside of cabinet](#)

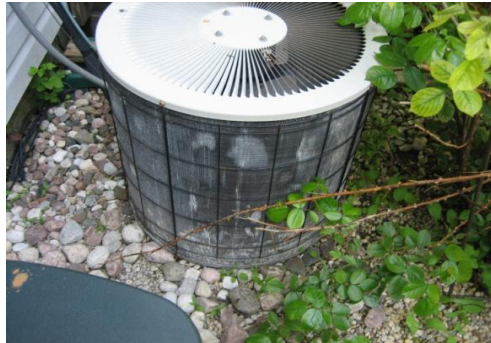
AIR CONDITIONER: overall cooling is presently adequate
old unit, continue servicing until replacement becomes necessary

Outdoor Coil: typical corrosion, reduced efficiency

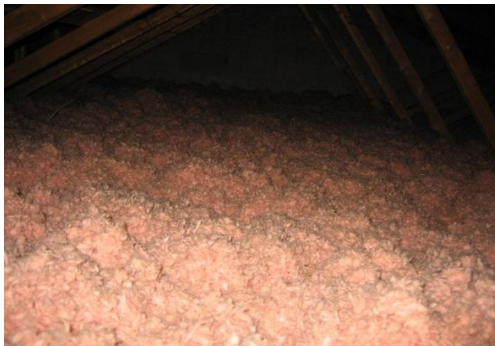
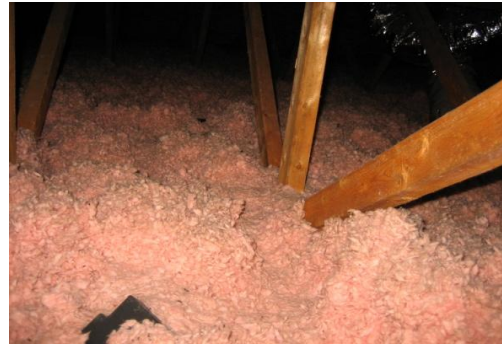
ROOF SPACE: insulation and ventilation is adequate

Note: adding insulation is considered an improvement rather than a repair
