HOME INSPECTION REPORT

21 Baby Point Rd

Toronto

Inspection Date: Sept 3 2020

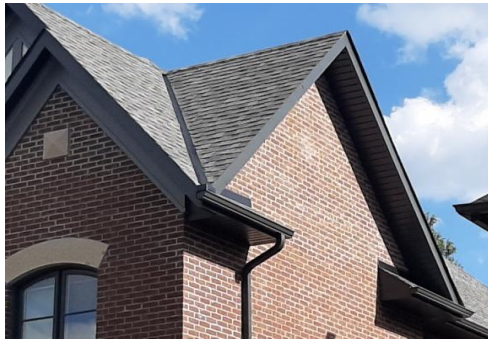
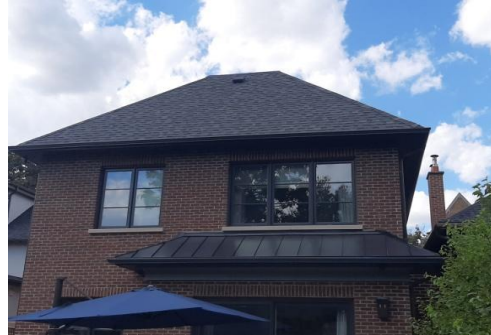
Sloped Surface: [new high quality shingles in good repair](#)

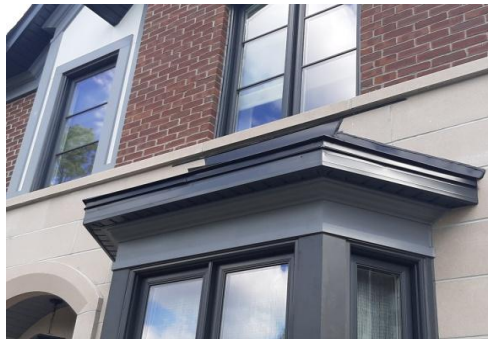
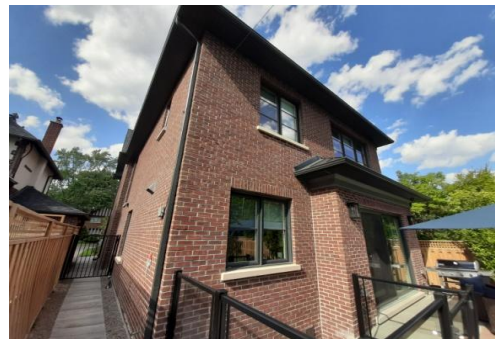
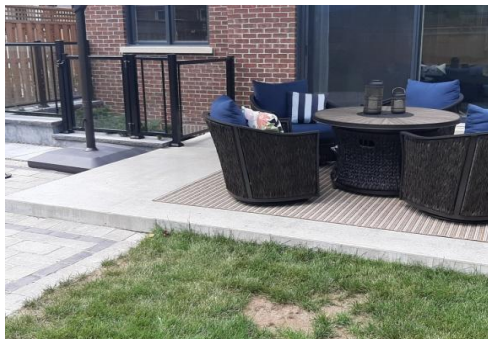
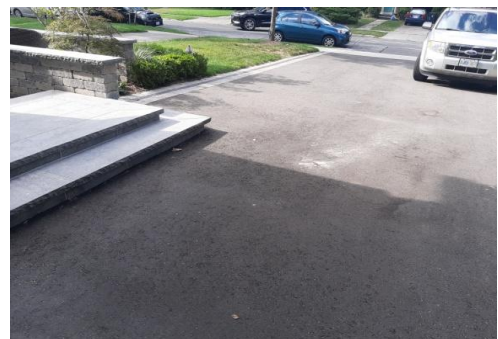
**Gutters/Downspouts: newly installed include leaf guards

**Walk(s)/Driveway(s): overall good installations

**Landscaping: overall good installations

WALL SURFACES: overall good installations

Soffit & Fascia: overall good installations

DOORS/WINDOWS: overall good installations

**Patio(s): overall good installations

Note: Maintain Gutters & Downspouts annually. Extend Downspouts at least 6-feet away from the house

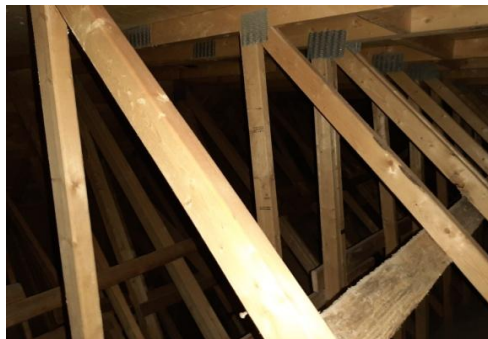
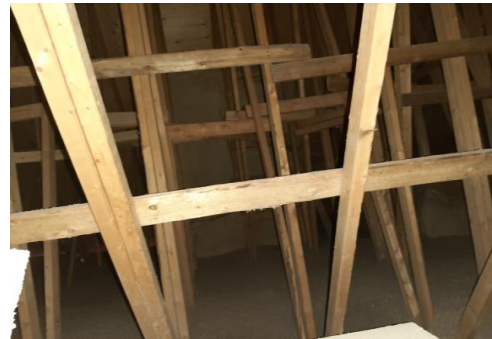
ROOF: new well built

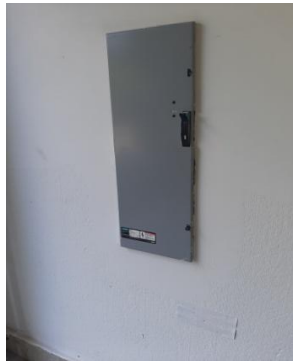
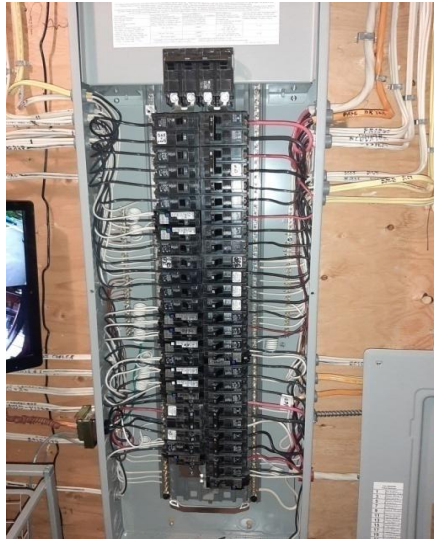
Main Disconnect: **newly installed in good condition**
SERVICE PANEL: **newly installed in good condition**

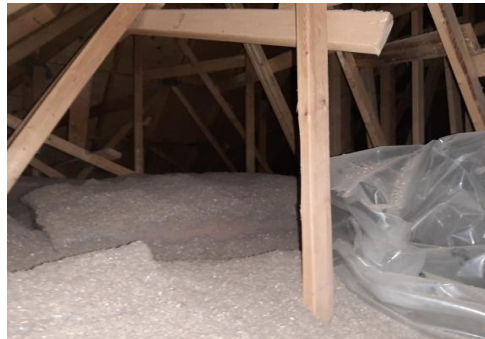
ROOF SPACE: [insulation above average and ventilation is adequate](#)
