HOME INSPECTION REPORT

238 Renforth Dr

Toronto

Inspection Date: May 15 2019

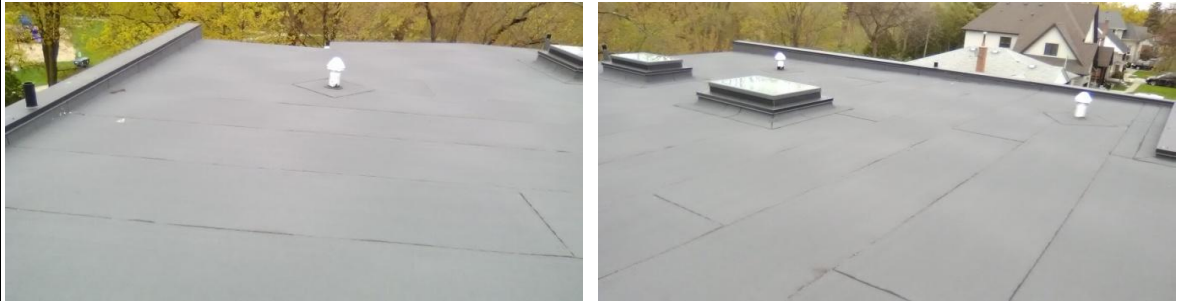
Flat Surface: [new surface](#)

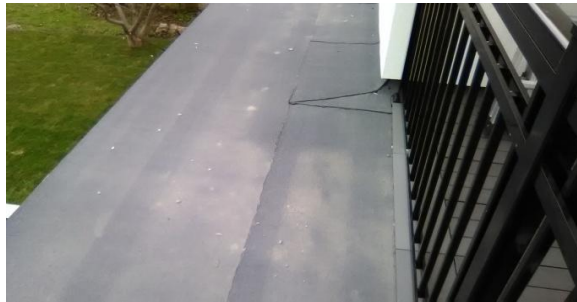
Lower Flat: [new surfaces \(limited visibility under decking\)](#)

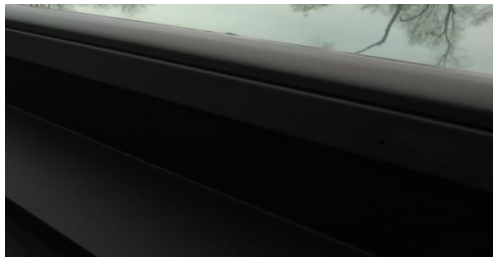
Skylight(s): [overall good installation, some fasteners missing along side of window frame](#)

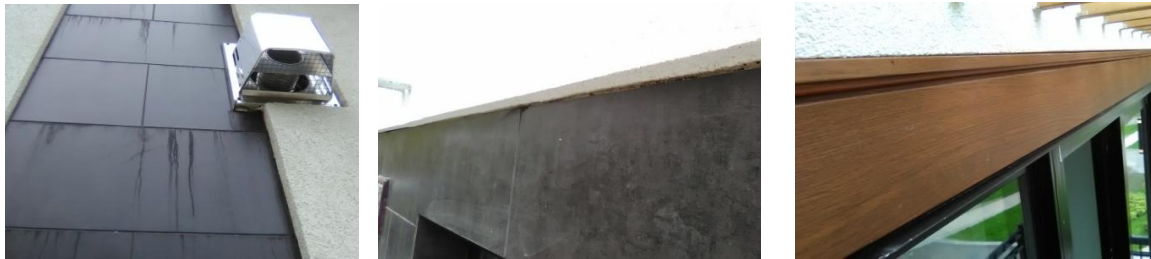
WALL SURFACES: newly installed
incomplete caulking along various wall seams, around wall vents
and piping/refrigerant lines

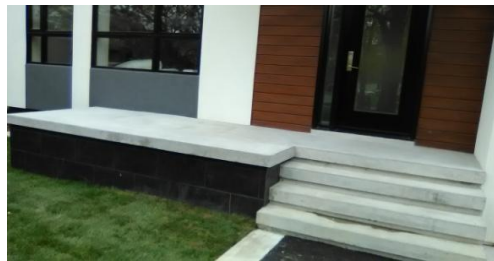
PORCH requires safety rails for deck and steps

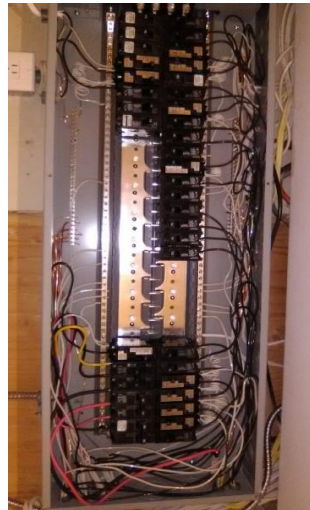
SERVICE PANEL: **new panel**

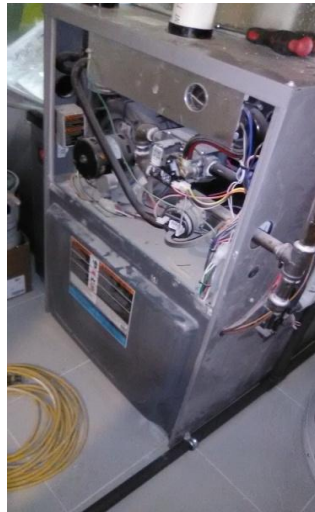
FORCED AIR FURNACE: [service annually, presently requires cleaning](#)

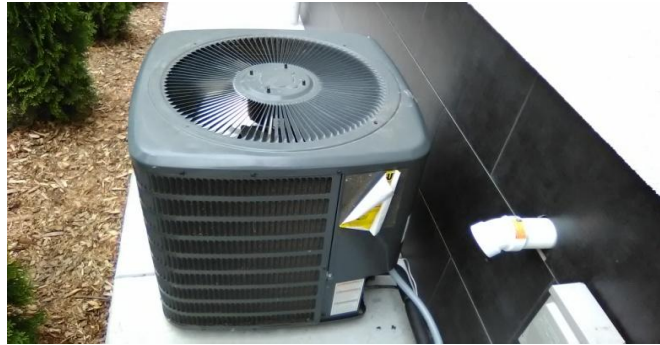
AIR CONDITIONER: not tested: should be serviced before using

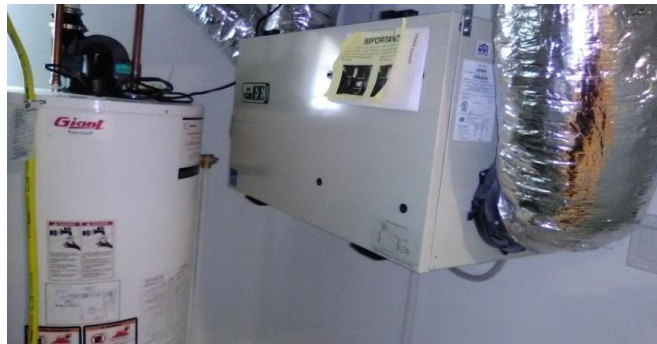
Heat Recover Ventilator: unit was not in use at time of inspection service before use

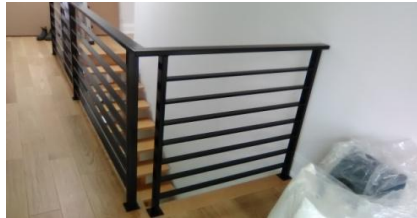
STAIRS: overall high quality installations
rails have horizontal spindles which are climbable- safety concern
