# HOME INSPECTION REPORT

27 Toffee Crt

Prepared for: Theodore Babiak

Inspection Date: May 10 2019

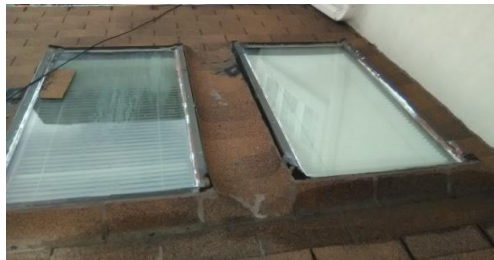
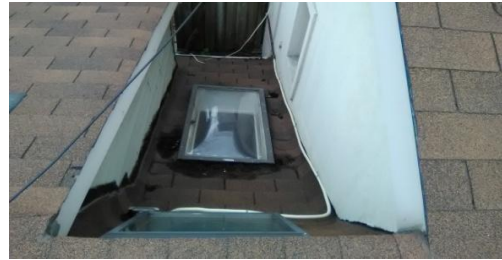
**ROOFING** The roof surfaces are approximately 10-yrs-old with a typical life expectancy of 15-20-yrs. Some areas require repairs. The porch shingles require replacement. The skylights require repairs.

Vulnerable Areas: [around skylights, suspect installations, monitor/repair flashing details](#)

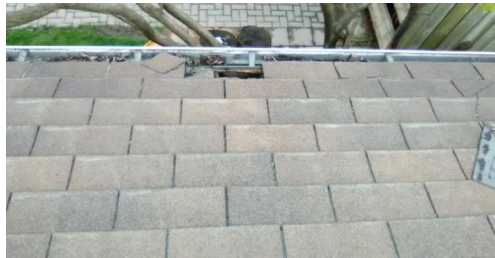
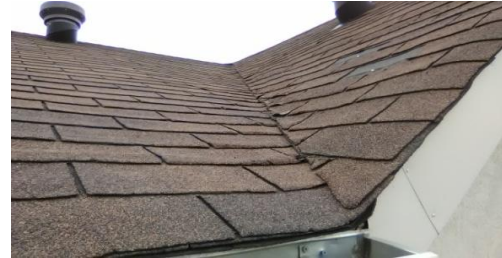
Sloped Surface: [requires repairs in some areas, missing shingles, overall majority of shingles are in good condition, some older shingles - replace within 3- yrs](#)

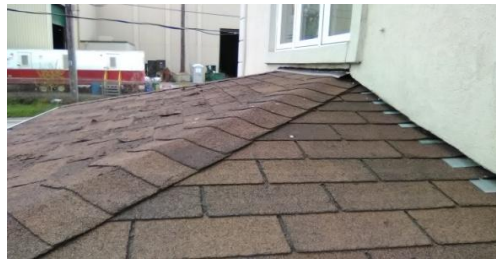
Porch(s): [older shingles - replace](#)

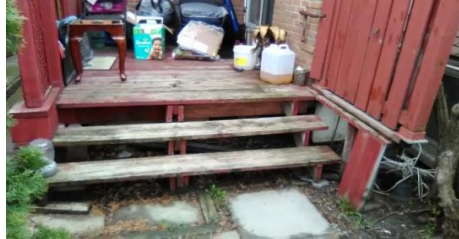
**DECK** older, repair and/or replace if more cost effective

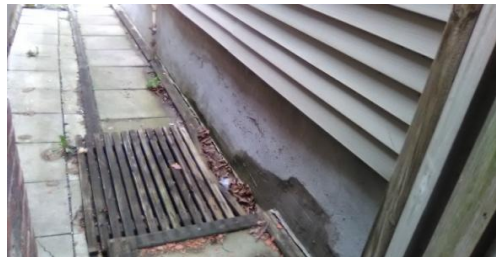
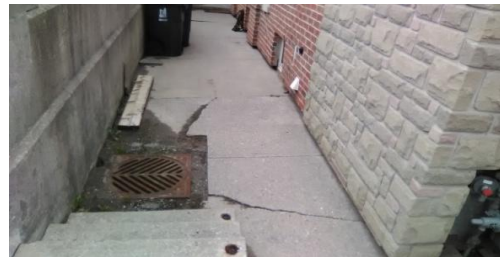
**\*\*Walk(s):** settlement, repair and slope away from house

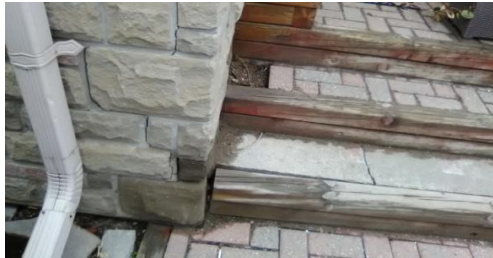
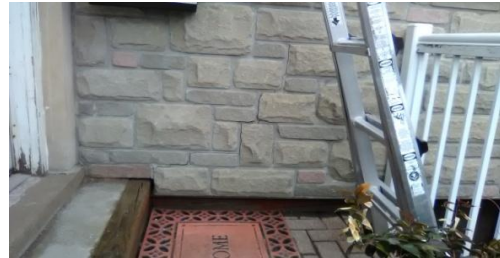
WALLS: stone veneer - minor settlement cracks- repair

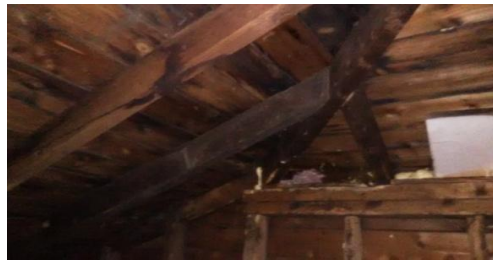
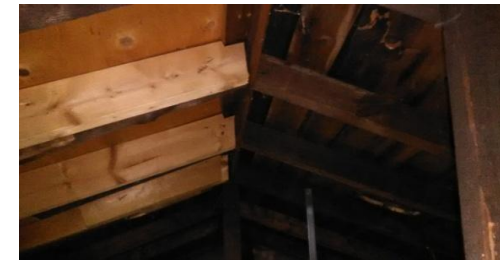
ROOF: overall in good repair, portion of rafters have been reinforced

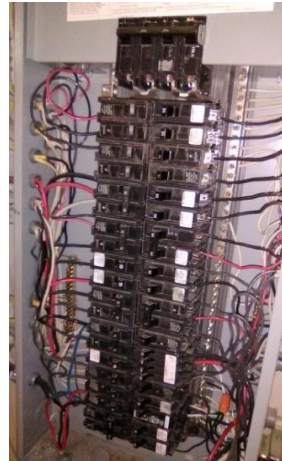
SERVICE PANEL: overall in good repair

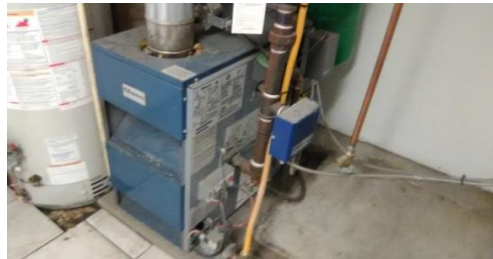
THERMOSTAT: [poor location - should be in central living area](#)  
HOT WATER BOILER: [service annually, typical rusting to burners and visible heat exchanger](#)  
[annual CO test mandatory for this type of unit](#)  
Piping: [leaking connections above boiler require repairs](#)

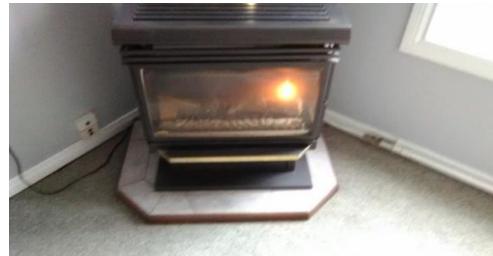
Comments: [rear extension is heated with gas fireplace - service annually](#)

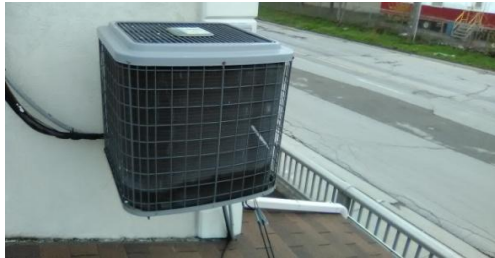
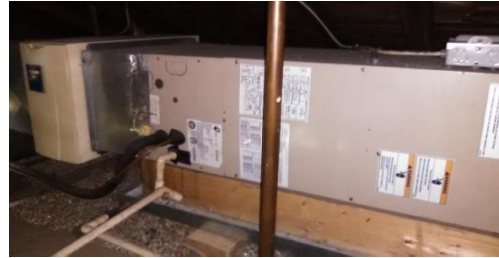
Attic Ductwork: air handler and ducts located in roof space  
filter requires replacement

aging unit, continue servicing until replacement becomes necessary

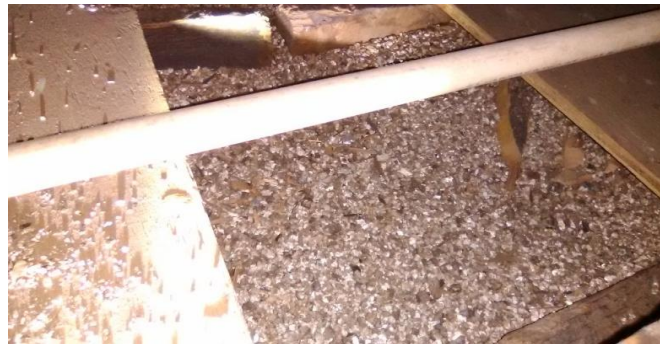
ROOF SPACE: vermiculite insulation may contain asbestos, leaving undisturbed is often the best approach, Environmental Consultants can assist if this is a concern

overall amount of insulation is low and should consider adding more insulation and installing a vapour barrier

Roof Access Hatch: insulate and weather-strip access hatch to roof space

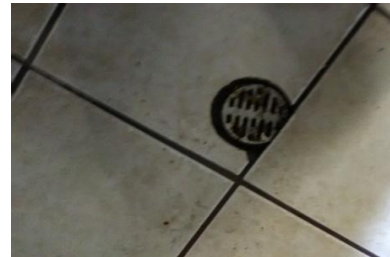
Floor Drain/Trap: boiler room: small diameter - trap not visible , suspect some back up,  
main drain: recommend video-scan, drain may require repairs  
recommend installing back flow valve
