HOME INSPECTION REPORT

274 Windermere Ave

Prepared by: Bob Papadopoulos P.Eng., RHI*

Inspection Date: Dec 3 2018

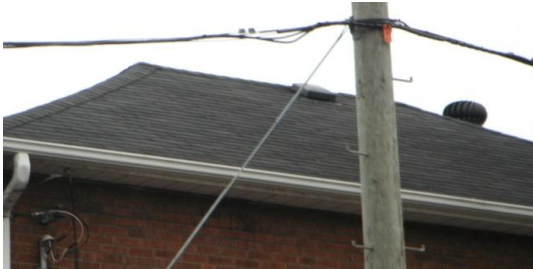
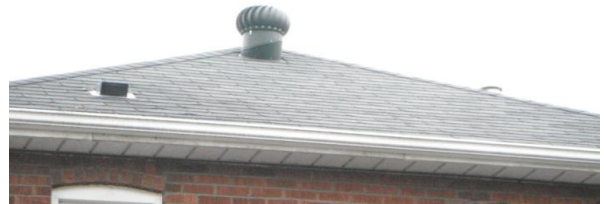
Sloped Surface: overall surface in good repair

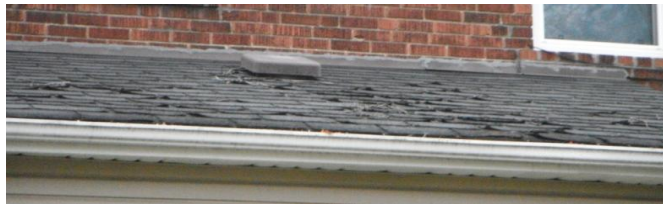
2nd Slope: cracking/curling, aging surface, budget to replace within 1-yr

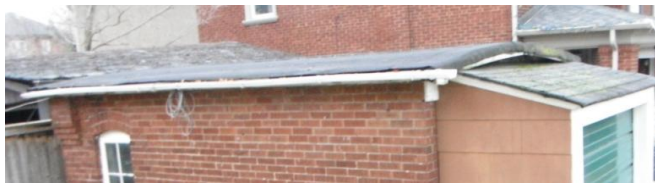
Garage: cracking/curling, aging surface, budget to replace within 1-yr

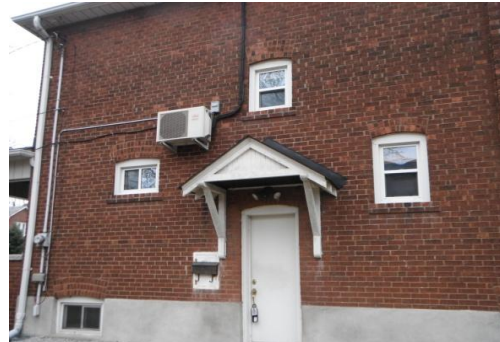
WALL SURFACES: overall in good repair
DOORS/WINDOWS: overall in good repair

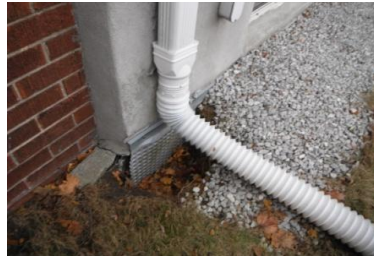
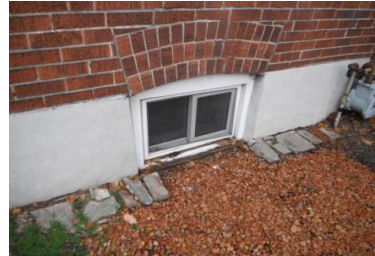
**Lot Grading: fill in gap at foundation corner, basement window - may require window well and/or threshold

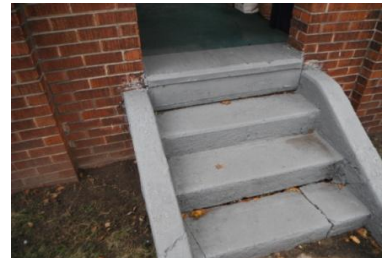
PORCH step settlement: repair cracks and monitor
provide hand rail

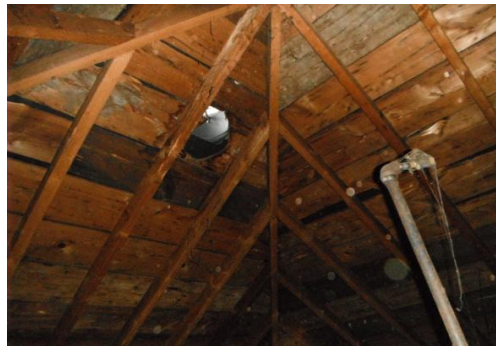
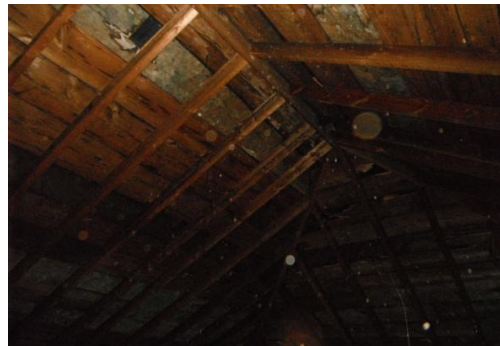
ROOF: overall in good repair

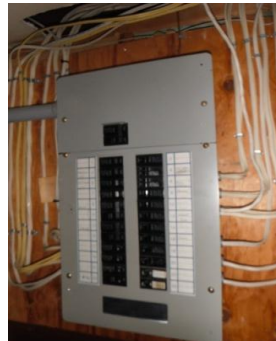
SERVICE PANEL: **overall in good repair**

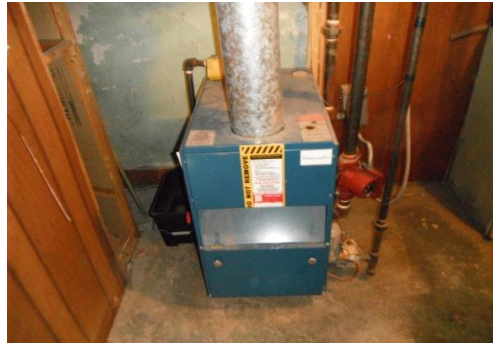
HOT WATER BOILER: [continue servicing until replacement becomes necessary](#)
[annual CO test mandatory for this type of unit](#)

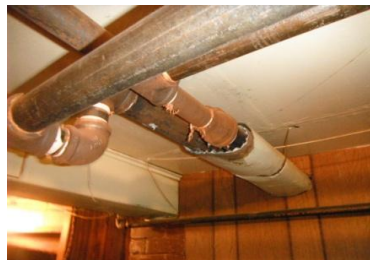
Piping: [insulation on pipes may contain asbestos](#)
[encapsulating the insulation is often the best approach](#)
[Environmental Consultants can assist if this is a concern](#)

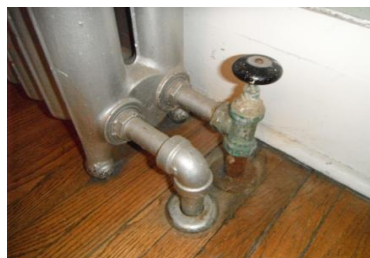
Radiator(s): [monitor and repair valves as required](#)

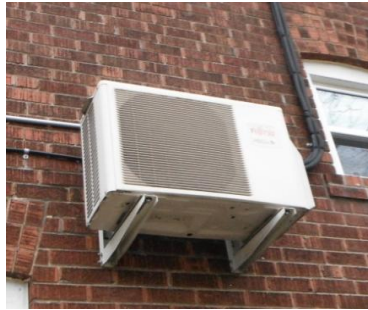
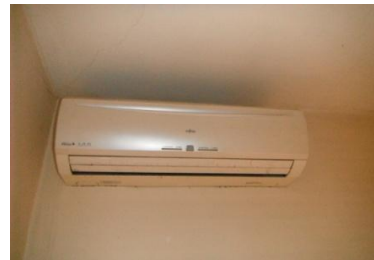
Ductless: aging unit, continue servicing until replacement becomes necessary

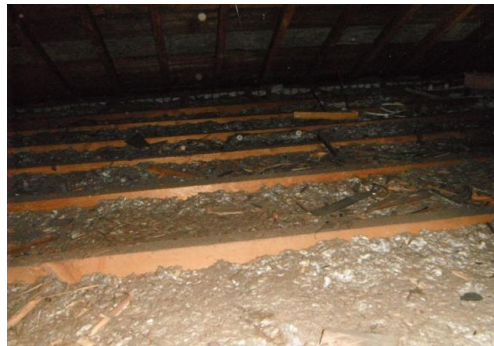
ROOF SPACE: below average insulation: upgrading insulation will improve comfort and efficiency
also recommend installing vapour barrier

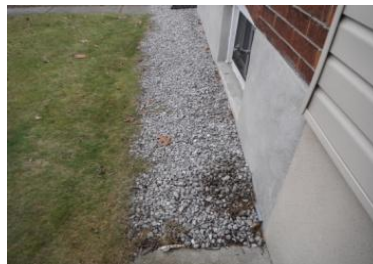
****Basement Leakage:** **the foundation has been damp-proofed which will minimize moisture in the basement**
