HOME INSPECTION REPORT

30A Thorndale Ave

Toronto

Inspection Date: Sept 3 2020

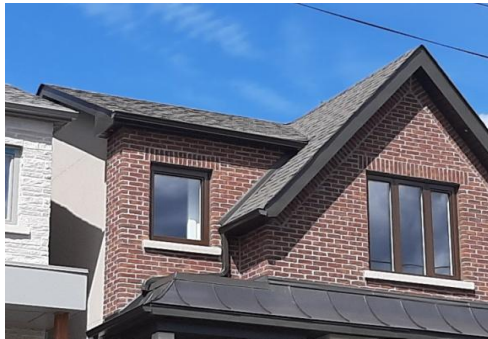
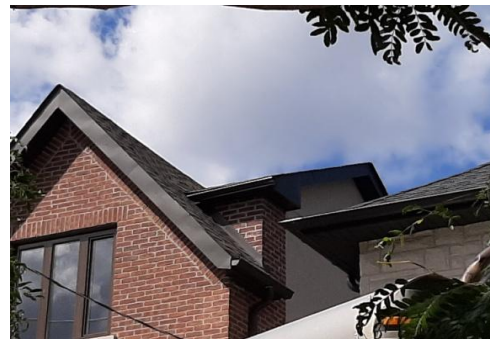
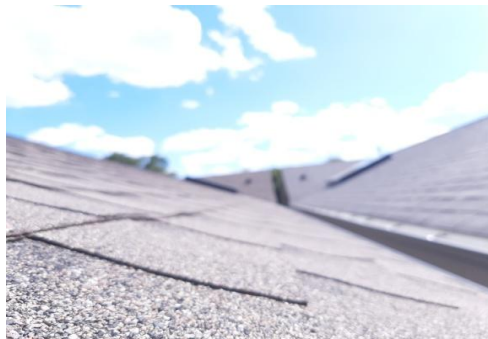
Sloped Surface: [new high quality shingles in good repair](#)

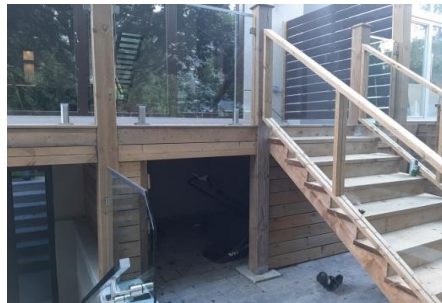
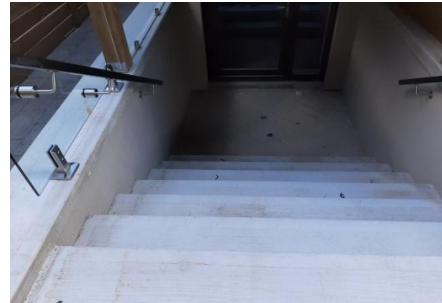
PORCH overall good installations

**BASEMENT WALKOUT: overall good installations

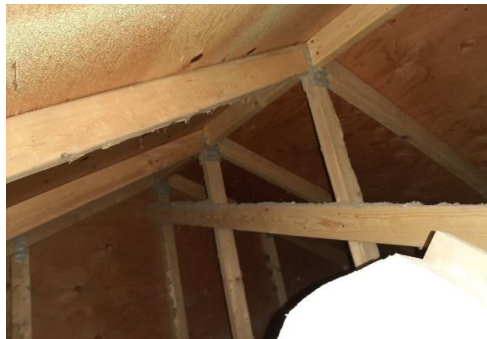
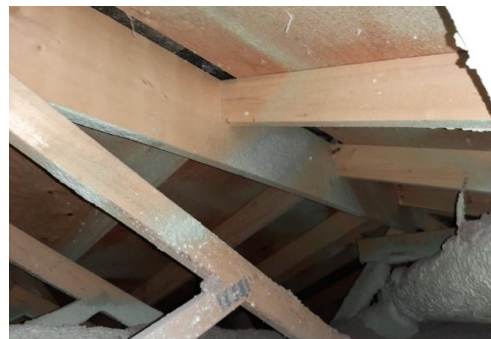
ROOF: new well built

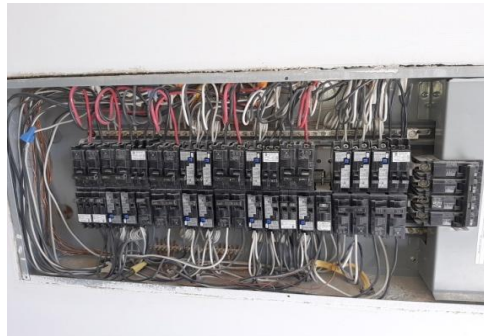
SERVICE PANEL: **newly installed in good condition**

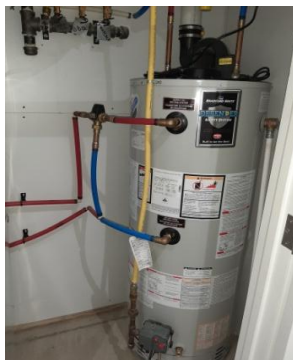
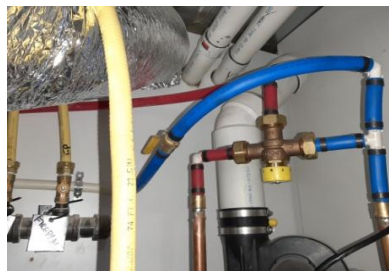
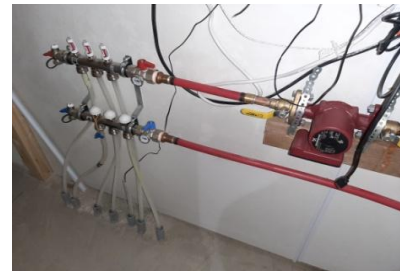
COMBINATION SYSTEM: [service annually](#)
[all piping examined was in good repair](#)

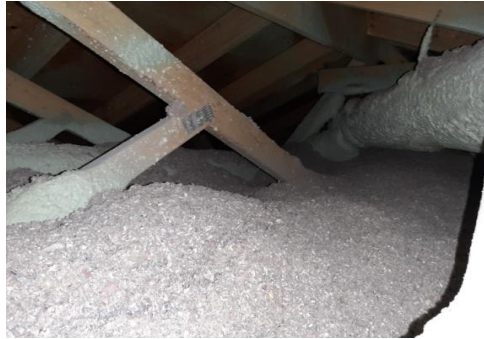
ROOF SPACE: [insulation above average and ventilation is adequate](#)

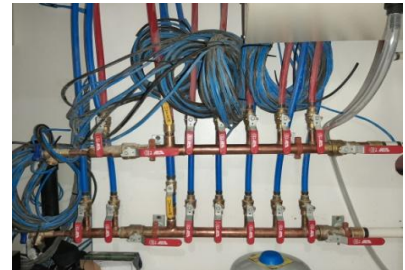
Washroom(s): overall good quality installations

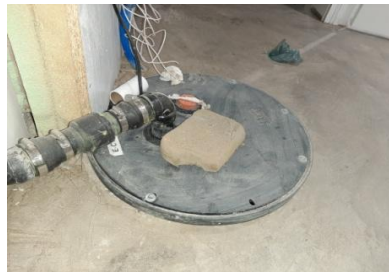
**Basement Leakage: the foundation has been damp-proofed which will minimize moisture
service sump pump annually
consider installing back up battery
