# HOME INSPECTION REPORT

436 Durie St

Toronto

Inspection Date: April 9 2019

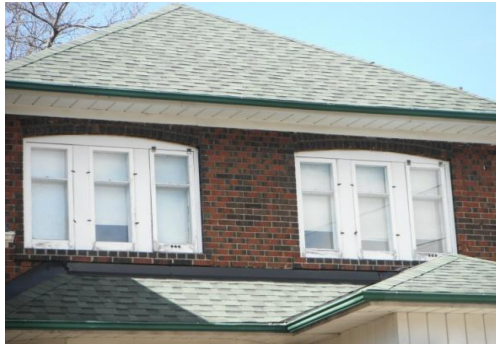
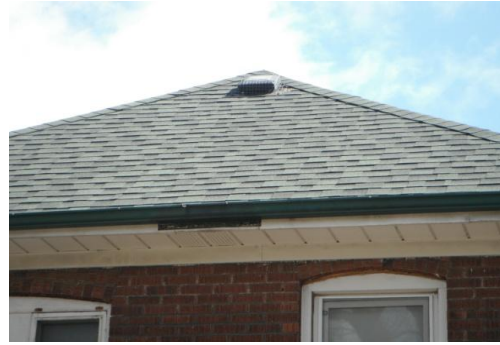
Sloped Surface: [newer surface in good repair](#)

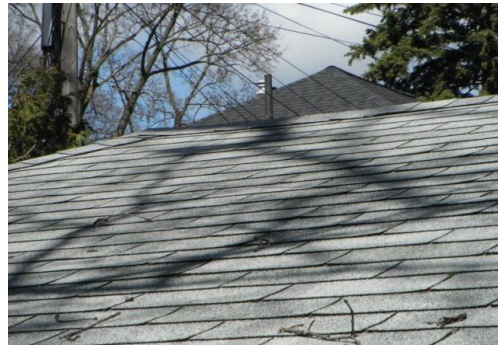
Garage: [overall surface in good repair](#)

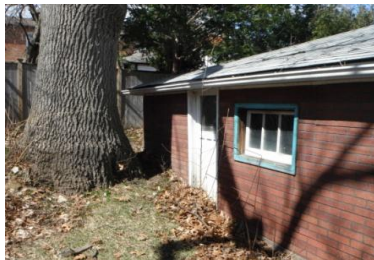
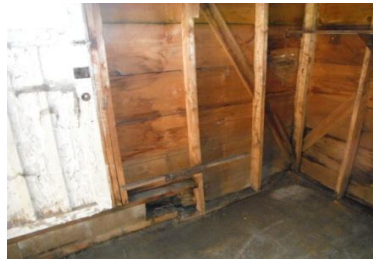
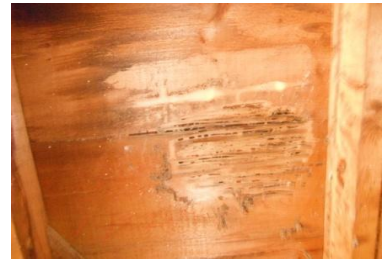
**DETACHED GARAGE:** overall in poor condition, rot damage, tree root damage, insect damage requires further evaluation by specialist to determine if infestation present, overall cost to repair will depend on approach

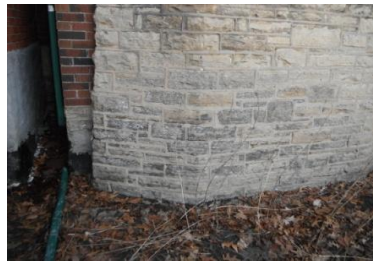
WALLS: overall in good repair  
Masonry: front stone requires general mortar maintenance

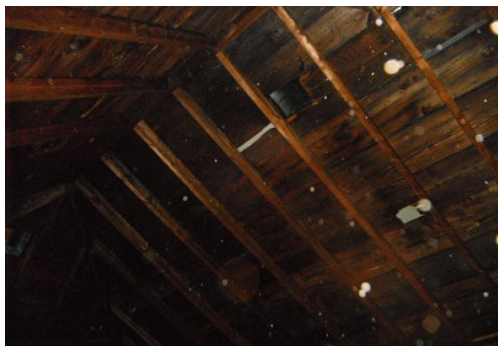
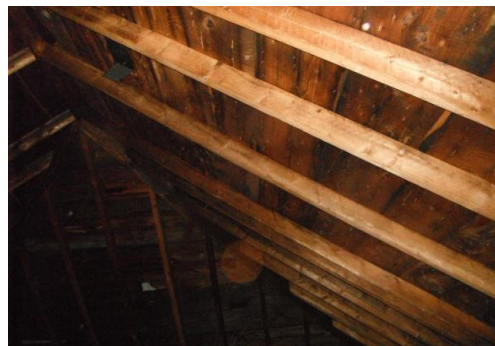
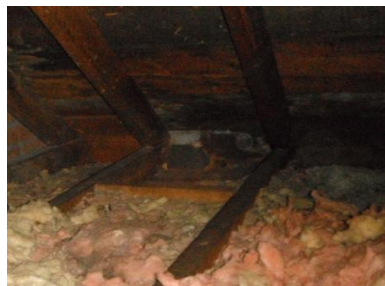
ROOF: overall in good repair  
minor squirrel damage on south side

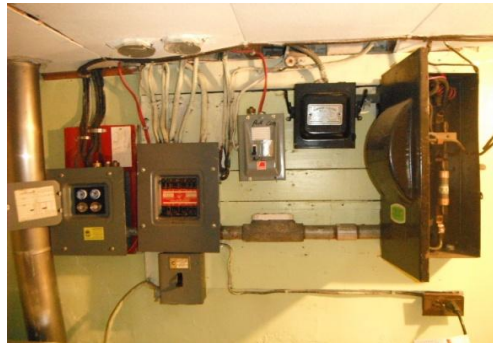
**SERVICE PANEL: older breaker panel with various sub panels, recommend upgrading to combination breaker panel**

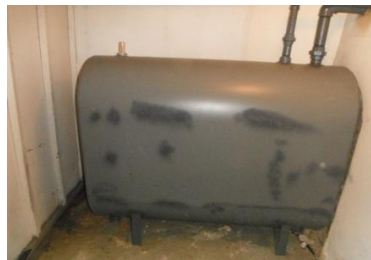
Oil Tank: [manufactured 2004, may require replacement for insurance purposes](#)

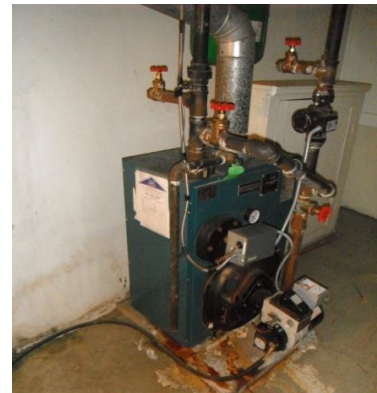
HOT WATER BOILER: [not tested -evidence of leaking, requires servicing, may require replacement, consider replacing with gas fired unit](#)

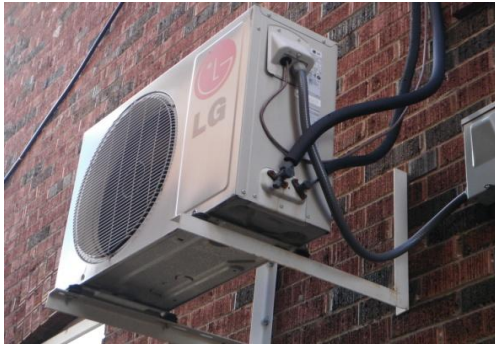
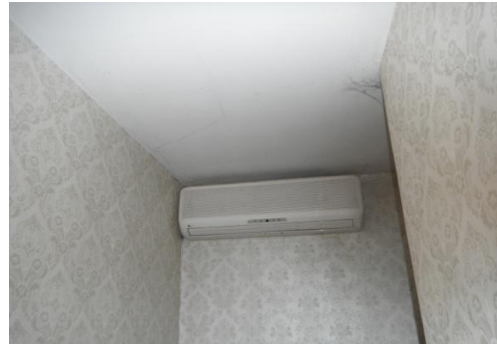
Ductless: not tested: should be serviced before using  
old unit, continue servicing until replacement becomes necessary

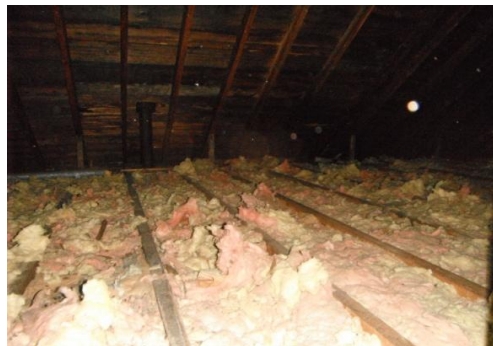
ROOF SPACE: recommend removing present insulation - suspect portion are soiled from prior squirrel activity  
install vapor barrier and insulation to standard level  
upgrading insulation will improve comfort and efficiency

Ventilation: recommend installing soffit vents with insulation upgrades

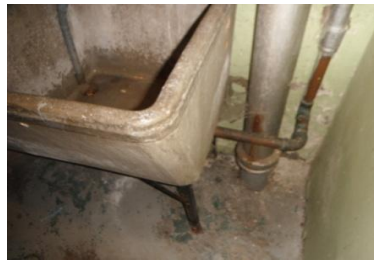
Piping: **newer clean out pipes at exterior front suggests upgrades to city sewer, recommend installing backflow valve in basement when renovating**
