# HOME INSPECTION REPORT

47 Tallon Rd

Inspection Date: Nov 8 2018

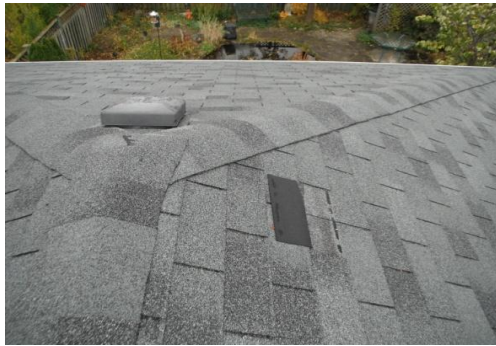
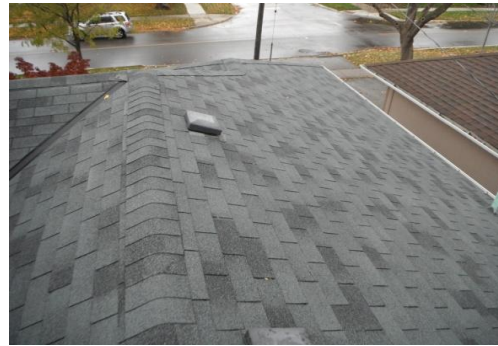
Sloped Surface: overall surface in good repair, minor repair at south, continue to monitor and repair as required

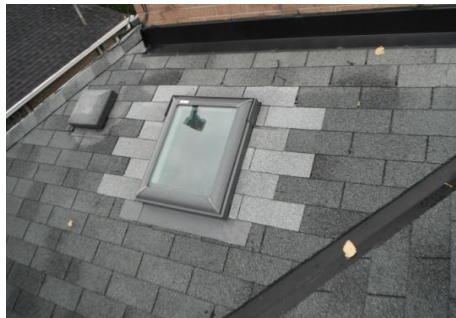
Skylight(s): overall in good repair

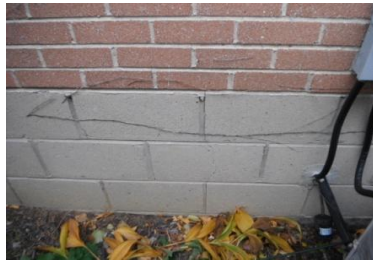
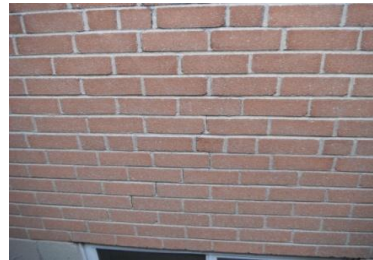
FOUNDATIONS: typical settlement crack west central side

WALLS: typical settlement crack east central side

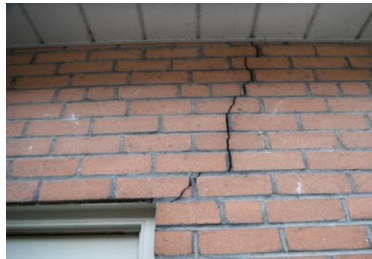
Masonry: northeast: garage settlement, overall due to age of house further settlement is not anticipated, repair crack and monitor

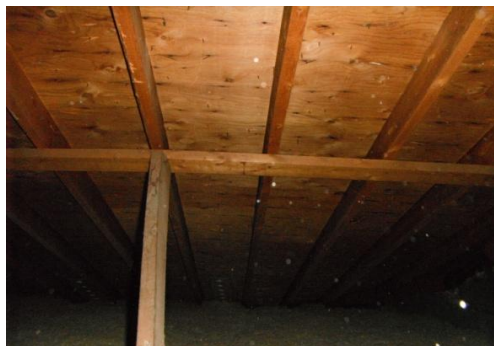
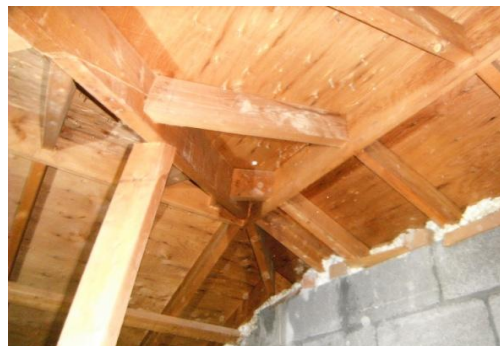
ROOF: overall in good repair

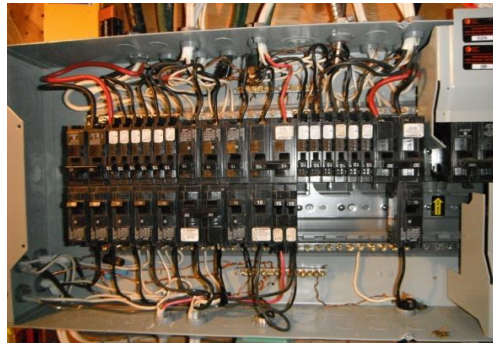
SERVICE PANEL: **overall in good repair**

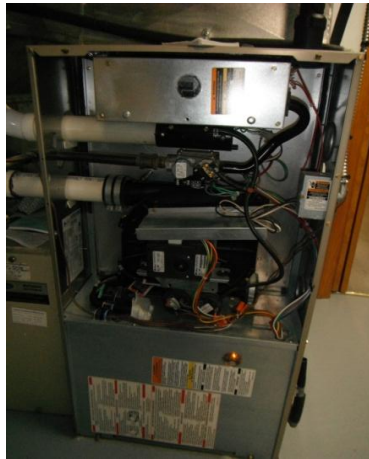
FORCED AIR FURNACE: [service annually](#)

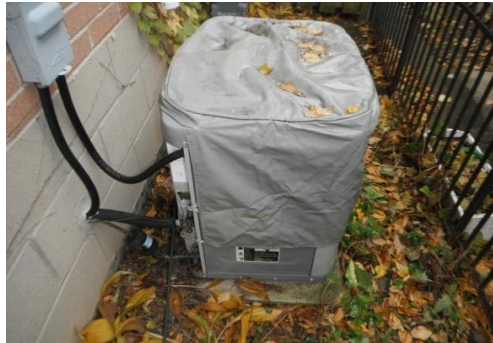
AIR CONDITIONER: not tested: should be serviced before using  
aging unit, continue servicing until replacement becomes necessary

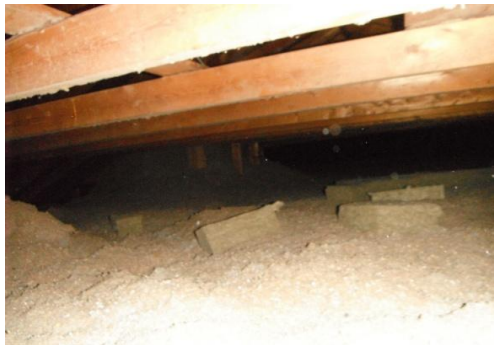
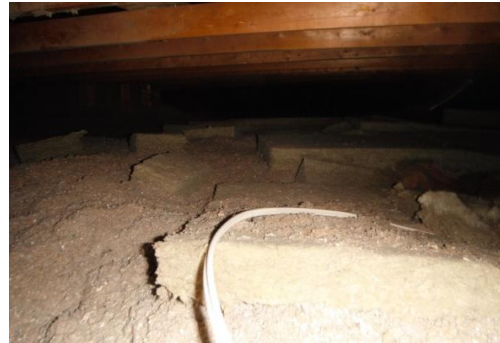
ROOF SPACE: insulation and ventilation has been upgraded
