# HOME INSPECTION REPORT

5 Brule Gardens

Toronto

Inspection Date: Aug 9 2018

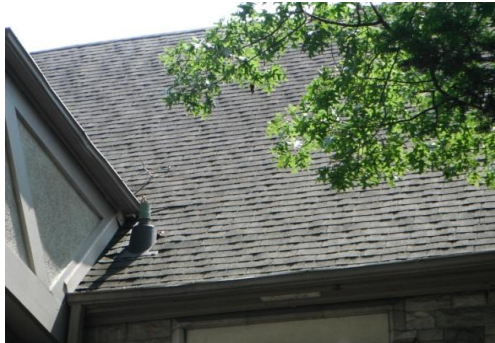
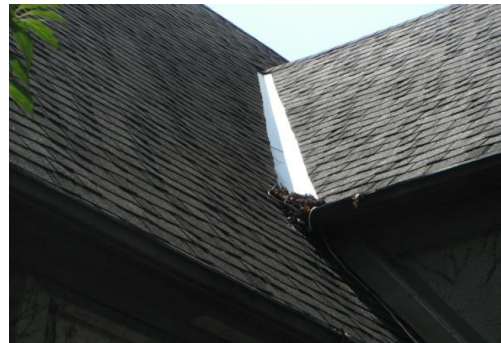
Sloped Surface: [front overall surface in good repair, majority of rear slope not visible due to height front valley requires cleaning](#)

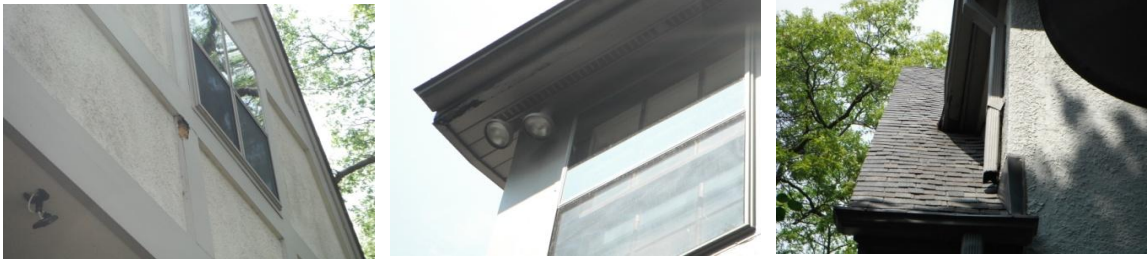
Stucco: overall in good repair, various wood trim components require repairs

Soffit & Facia: require general repairs and maintenance at southeast mainly

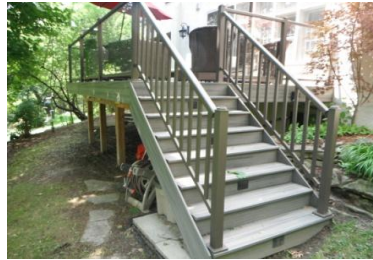
DECK overall well built, high quality composite materials

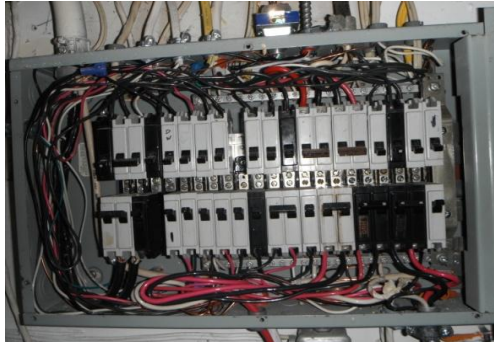
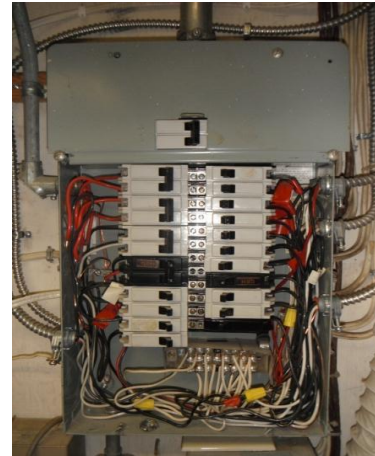
SERVICE PANEL: **overall in good repair**  
Auxiliary Panel: **overall in good repair**

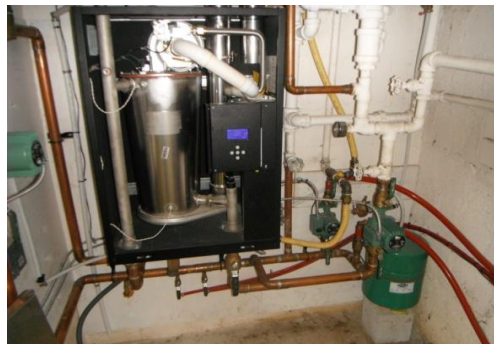
HOT WATER BOILER: combination system (provides domestic hot water as well)  
service annually  
system is equipped with 3 pumps for zone heating that improves  
overall comfort and efficiency

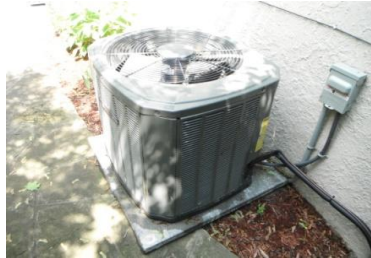
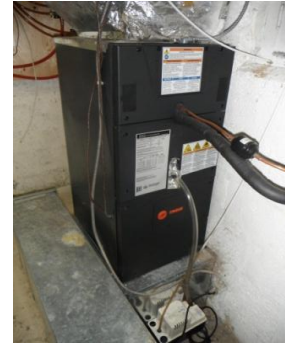
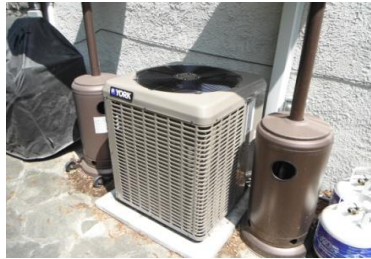
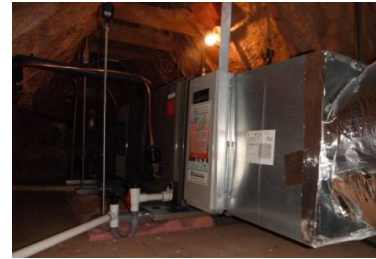
AIR CONDITIONER: 2 units with air handler in basement and roof space, overall performance is adequate service annually

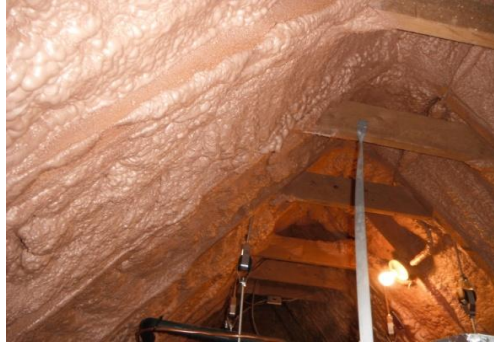
ROOF SPACE: only southwest roof accessible: insulation is above average

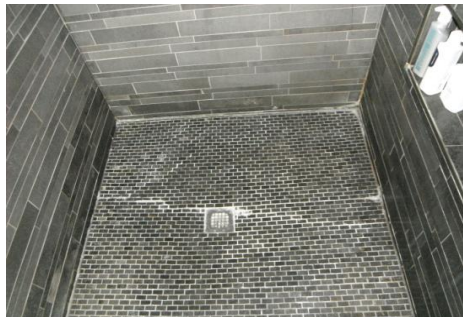
Washroom Shower: master washroom: shower floor tile: monitor and maintain as required

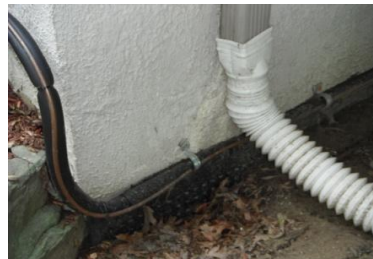
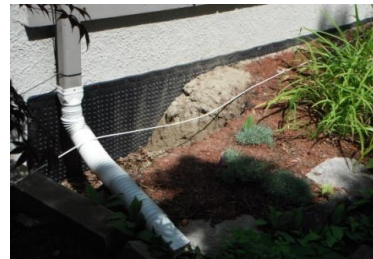
\*\*Basement Leakage: presently no concerns, see Steps below  
 typical efflorescence, staining and dampness for older foundation  
 some areas of the foundation have been damp-proofed from the  
 exterior to minimize risk of basement leaking

- gutters, downspouts, grading, driveways: ongoing maintenance and repair/see Exterior
- cracks/form ties on foundation: monitor/repair as required
- excavation/damp-proofing: monitor basement, consider step 3 as a last resort
