HOME INSPECTION REPORT

5 Sousa Mendes St #503

Prepared by: Bob Papadopoulos P.Eng., RHI*

Inspection Date: Jan 18 2019

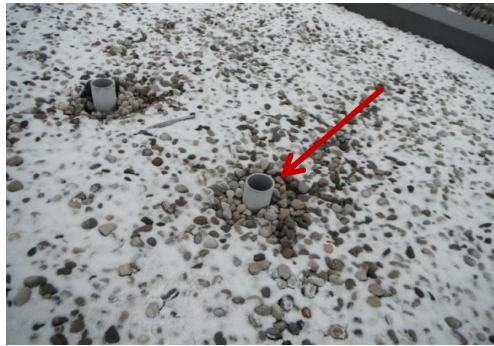
Flat Surface: [limited visibility, monitor drains - service annually](#)
Plumbing Stack: [upper roof: extend 1-ft above roof line](#)

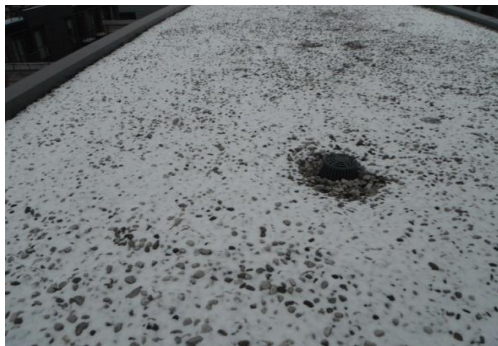
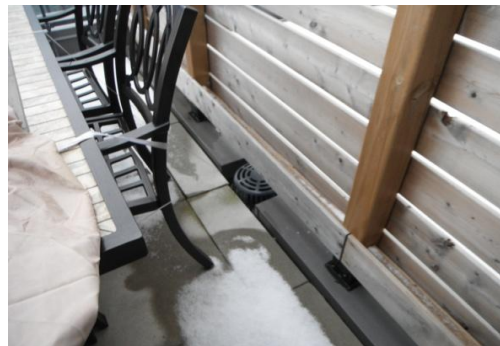
[monitor roof drains and service as required](#)

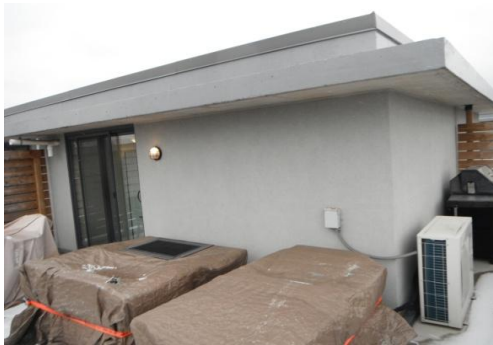
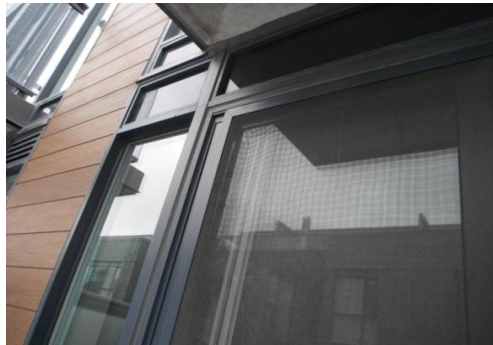
overall well maintained

Note: Maintain Gutters & Downspouts annually. Extend Downspouts at least 6-feet away from the house

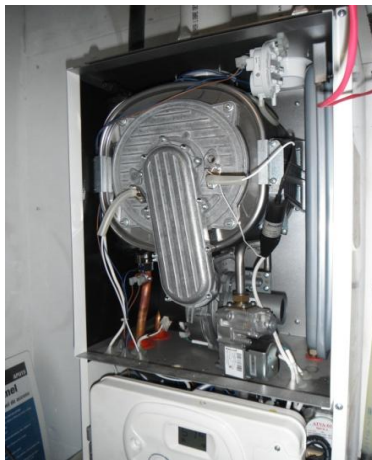
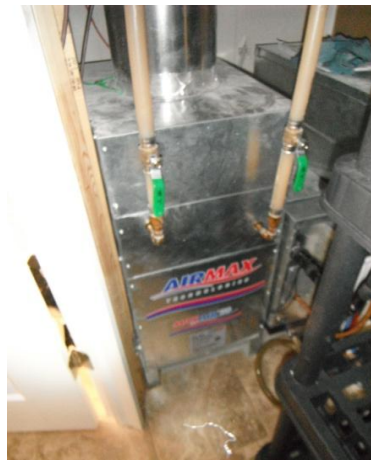
COMBINATION SYSTEM: [on demand water heart provides heating to forced air handler, service annually](#)

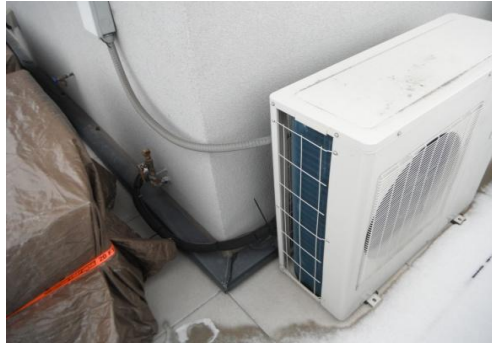
AIR CONDITIONER: not tested: should be serviced before using
