HOME INSPECTION REPORT

5 Sousa Mendes St #503

Toronto

Inspection Date: Jan 18 2019

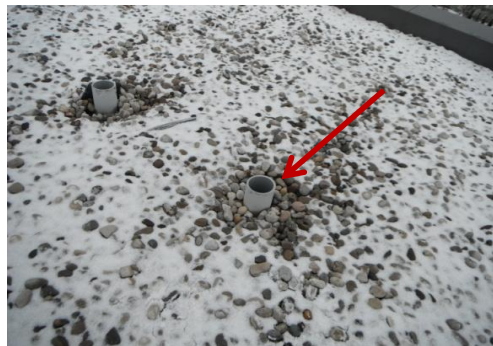
Flat Surface: [limited visibility, monitor drains - service annually](#)
Plumbing Stack: [upper roof: extend 1-ft above roof line](#)

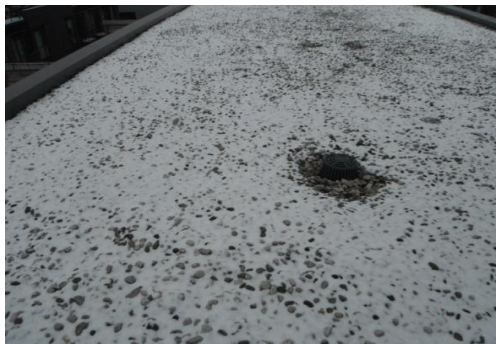
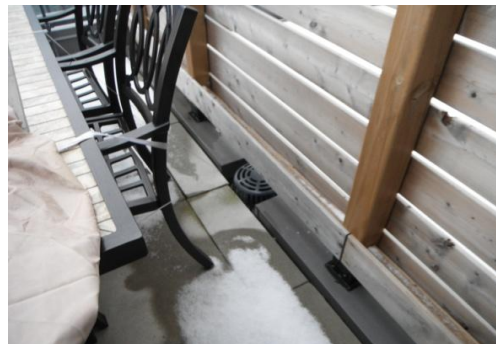
[monitor roof drains and service as required](#)

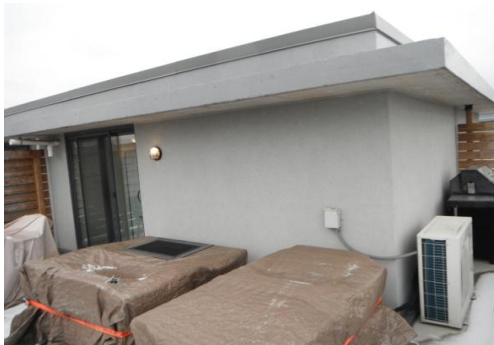
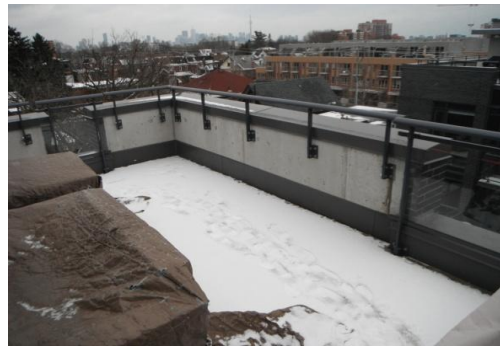
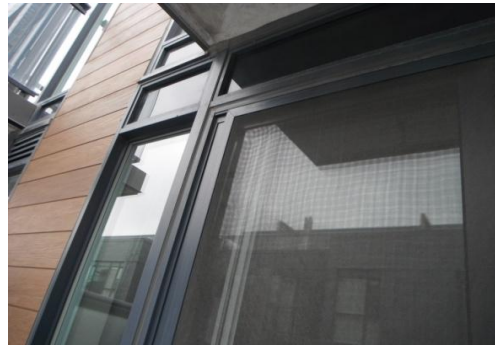
overall well maintained

Note: Maintain Gutters & Downspouts annually. Extend Downspouts at least 6-feet away from the house

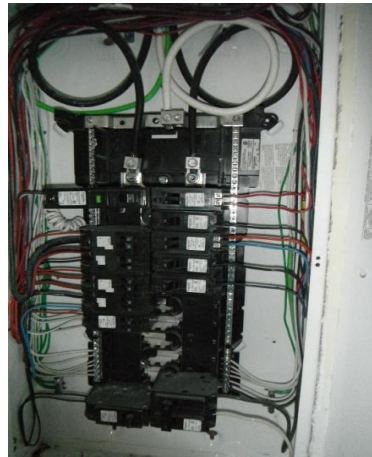
SERVICE PANEL: **overall in good repair**

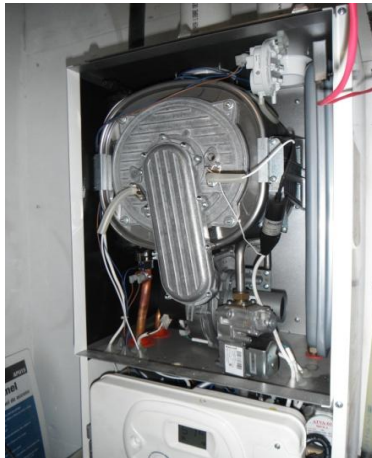
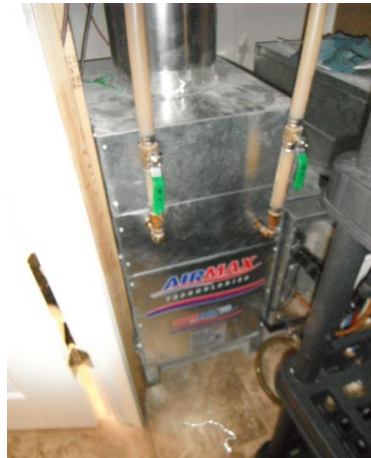
COMBINATION SYSTEM: [on demand water heater \(boiler\) provides heating to forced air handler, service annually](#)

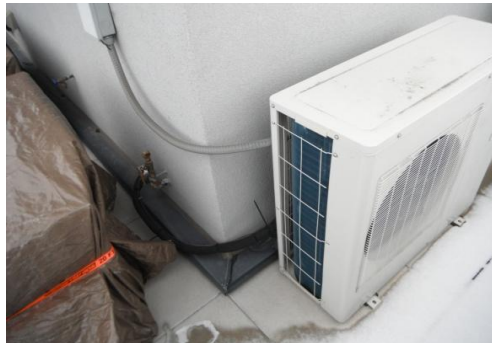
AIR CONDITIONER: not tested: should be serviced before using
