# HOME INSPECTION REPORT

66 Fernalroy Blvd

Toronto

Inspection Date: Feb 21 2019

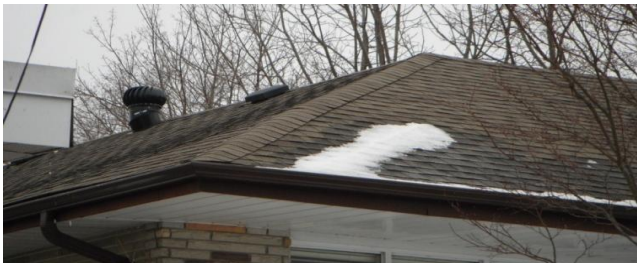
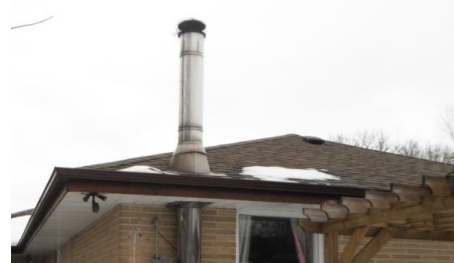
Sloped Surface: [overall surface in good repair](#)

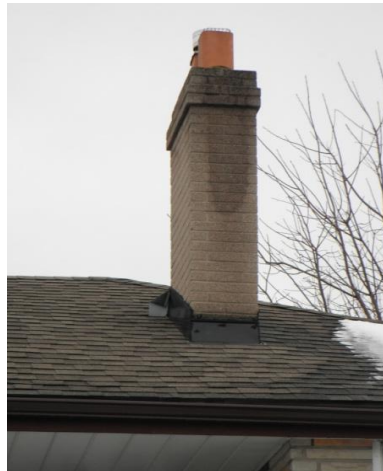
Chimney(s): [in good repair](#)

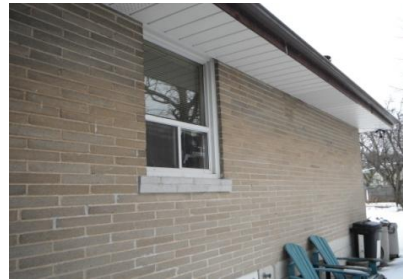
WALL SURFACES: overall well maintained  
DOORS/WINDOWS: overall well maintained

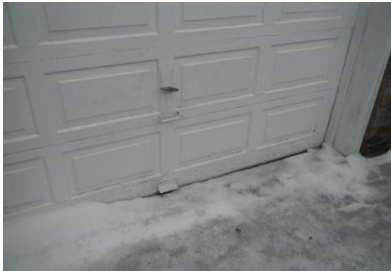
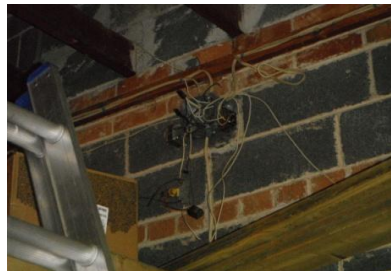
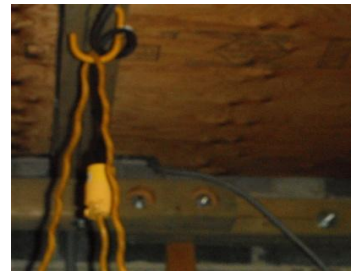
ATTACHED GARAGE: car door requires maintenance, electrical wires loose/exposed - repair, provide outlet for garage door opener,

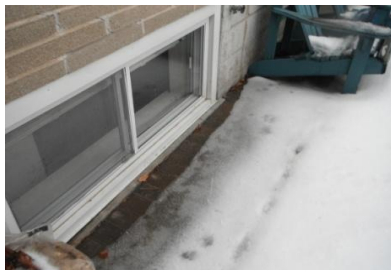
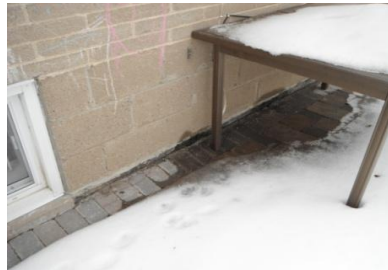
\*\*Walk(s): seal gaps along wall to minimize risk of moisture in basement

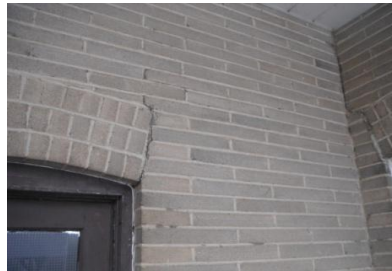
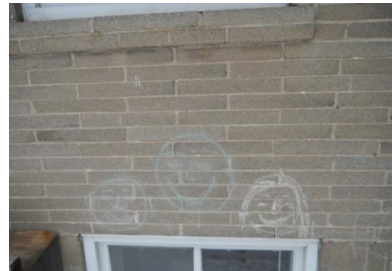
Masonry: typical cracks not critical, monitor and repair if required

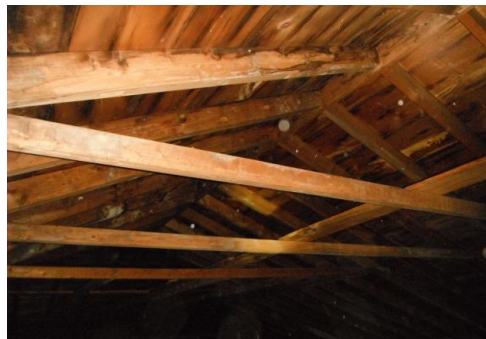
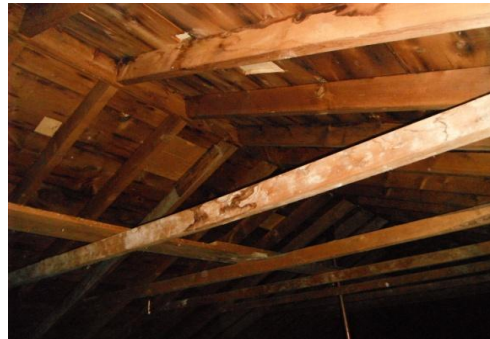
ROOF: overall in good repair

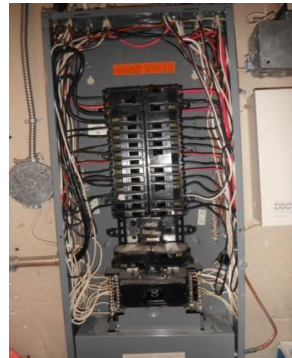
SERVICE PANEL: **overall in good repair**

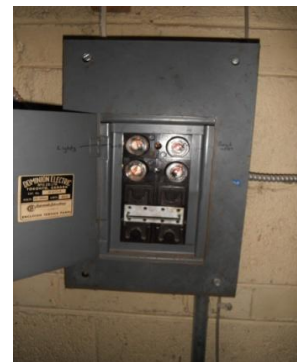
Auxiliary Panel: **overfused units- replace with 15 AMP fuses, overall consider upgrading to breaker panel**

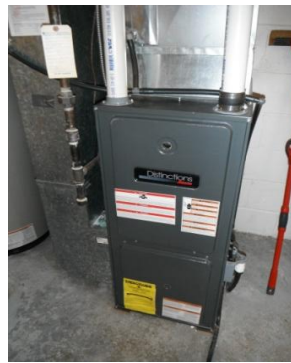
FORCED AIR FURNACE: [service annually](#)

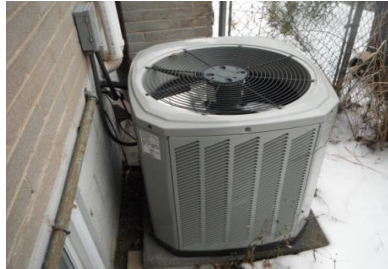
AIR CONDITIONER: not tested: should be serviced before using

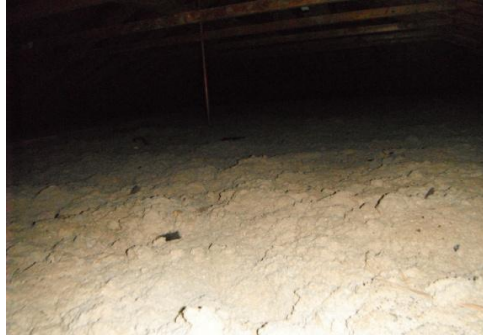
ROOF SPACE: upgrading insulation will improve comfort and efficiency  
Roof Access Hatch: insulate and weather-strip access hatch to roof space
