# HOME INSPECTION REPORT

68 Humber Trail

Toronto

Inspection Date: May 15 2019

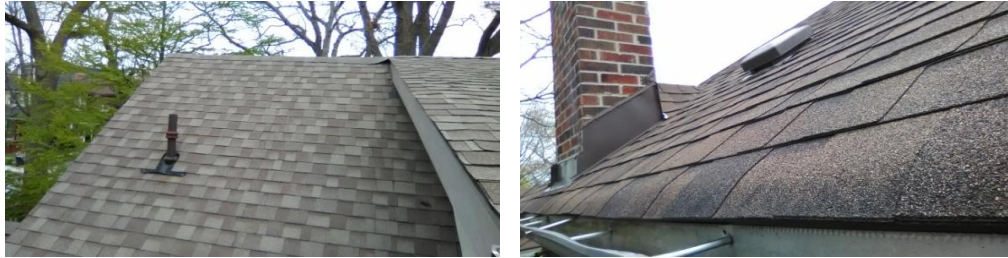
Sloped Surface: [overall surface in good repair](#)

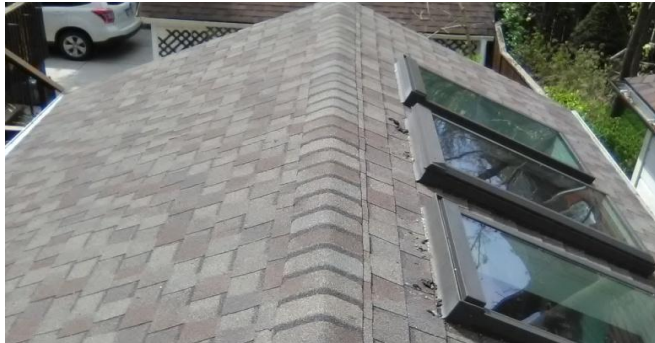
2nd Slope: [overall surface in good repair](#)  
[skylights in good repair](#)

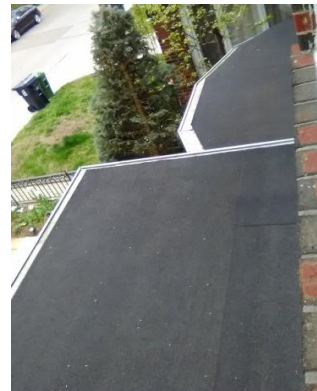
Flat Surface: [front overhang and bay in good repair](#)

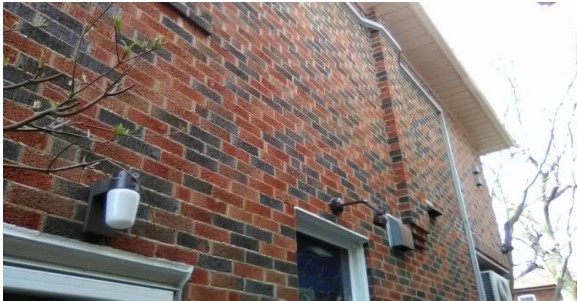
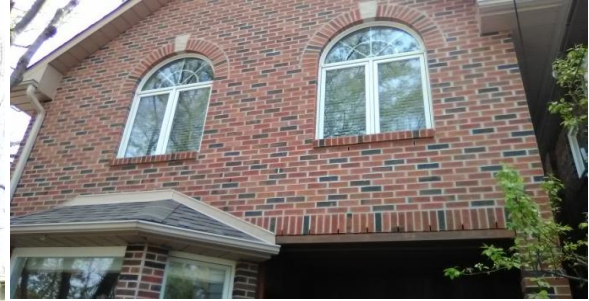
WALL SURFACES: overall in good repair  
DOORS/WINDOWS: overall in good repair

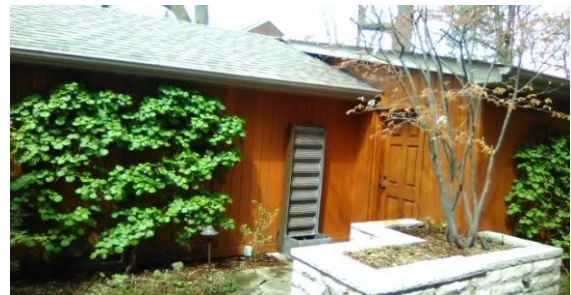
well built coach house

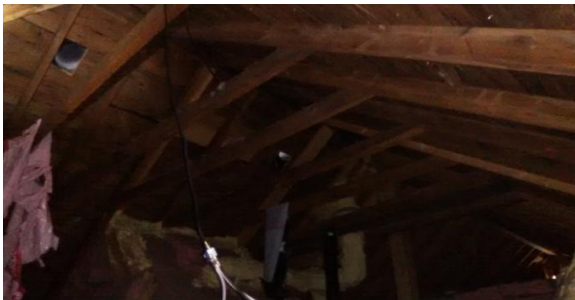
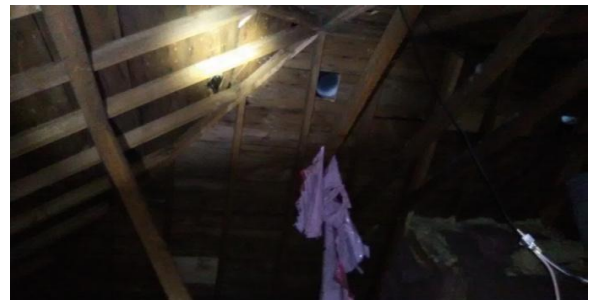
WALLS: in good repair

ROOF: overall in good repair

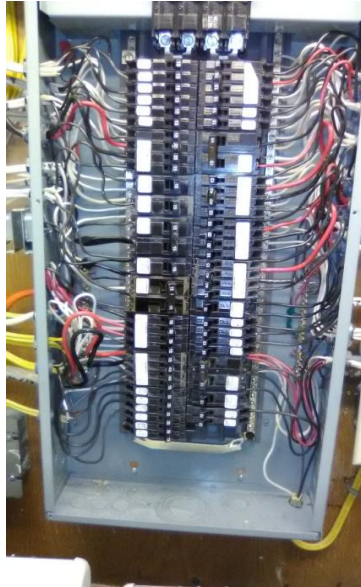
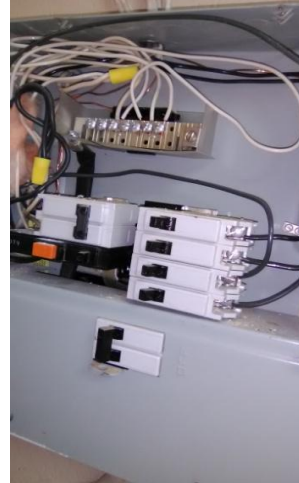
SERVICE PANEL: overall in good repair, some double tap breakers- not critical  
Auxiliary Panel: overall in good repair

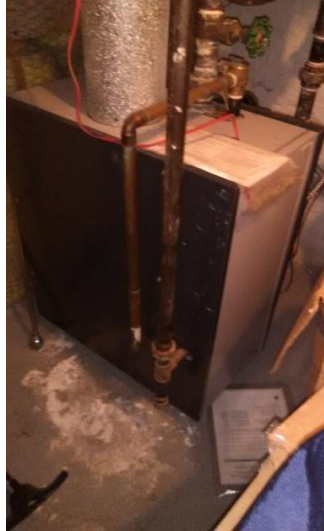
HOT WATER BOILER: service annually  
annual CO test mandatory for this type of unit

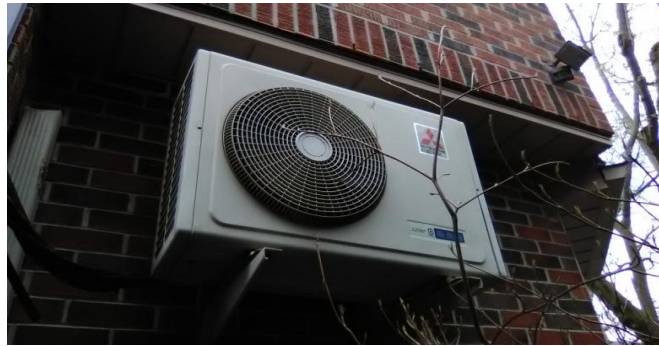
Ductless: not tested: should be serviced before using old unit, continue servicing until replacement becomes necessary

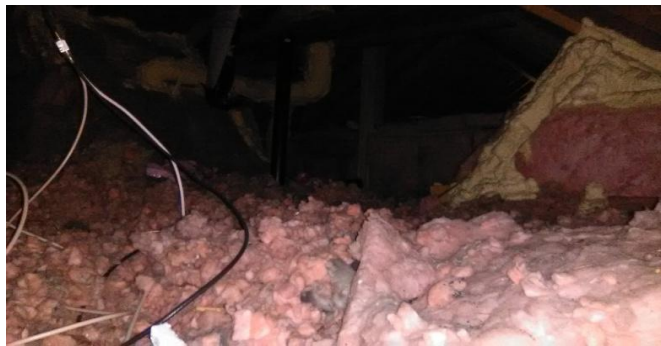
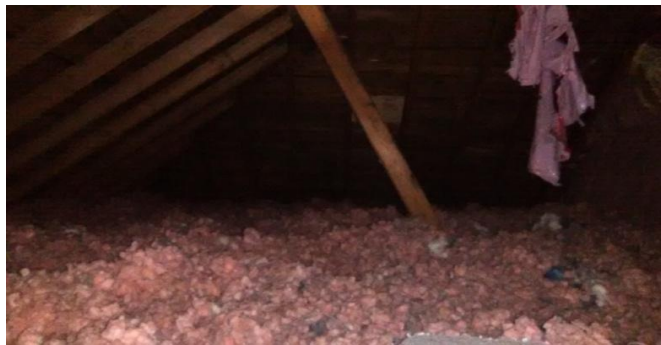
ROOF SPACE: insulation has been upgraded - should be more evenly distributed  
the skylights are well insulated with spray foam

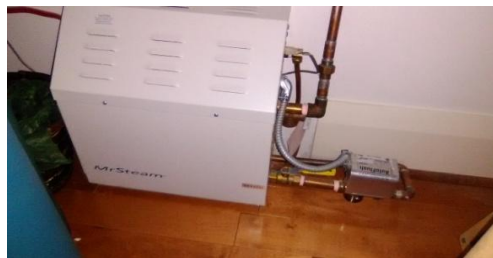
Comments: steam generator should have drip pan
