HOME INSPECTION REPORT

71 Laws St

Toronto

Inspection Date: Aug 30 2019

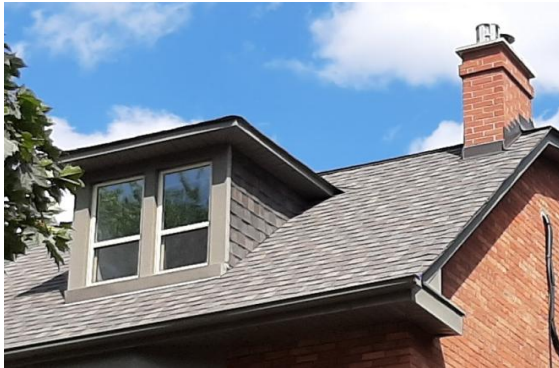
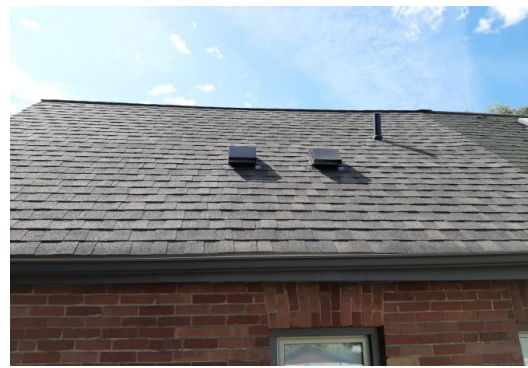
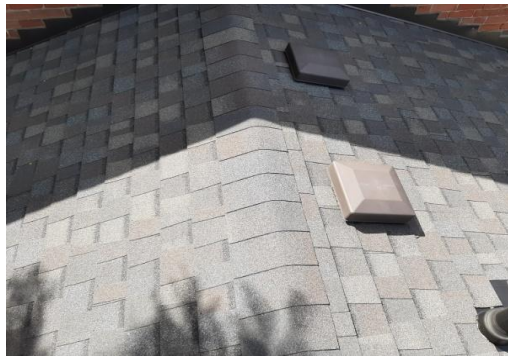
Sloped Surface: **newer surface in good repair**

Chimney(s): **rebuilt and in good repair**

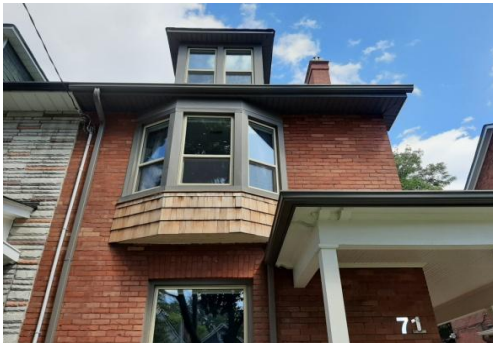
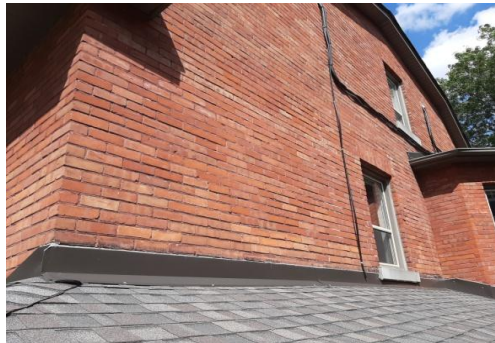
**Gutters/Downspouts: recently installed
Soffit & Fascia: recently installed
WALL SURFACES:
Brick: brick has been surfaced cleaned and in good repair
DOORS/WINDOWS: upgraded

Note: Maintain Gutters & Downspouts annually. Extend Downspouts at least 6-feet away from the house

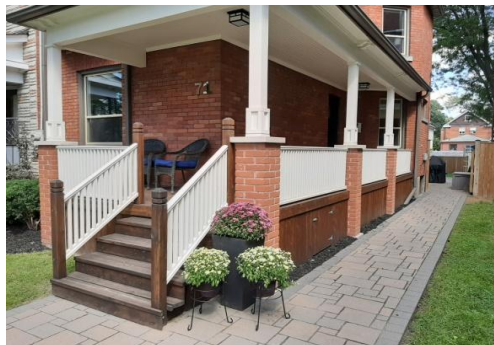
PORCH newly built
DECK newly built

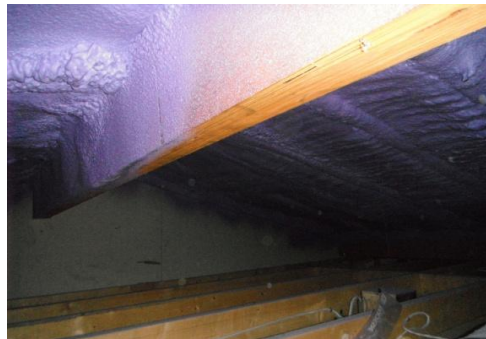
ROOF: in good repair and includes newly installed party wall (fire wall)
new ridge beam

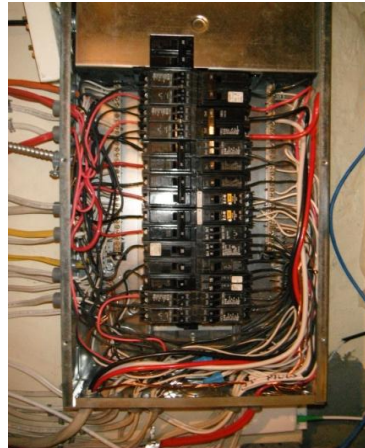
SERVICE PANEL: **new panel in good repair**

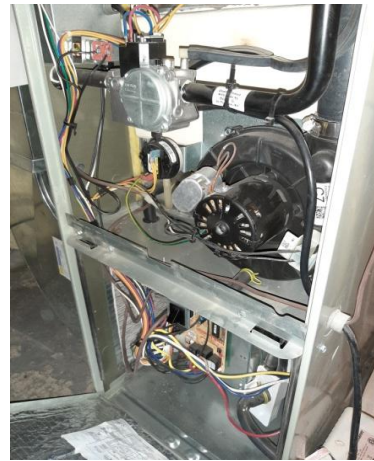
Ducts: appear to be upgraded

FORCED AIR FURNACE: service annually

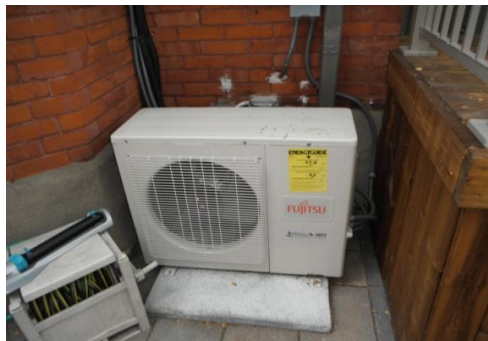
Multi-Split Ductless: [service annually](#)
[located in 3rd level two bedrooms](#)

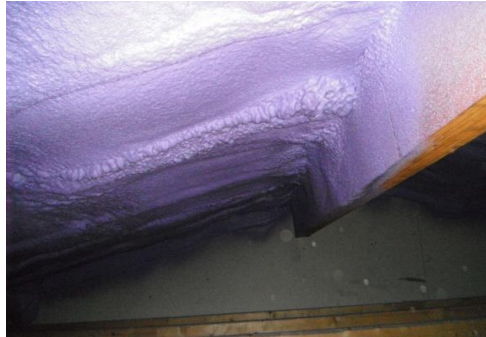
ROOF SPACE: [new spray foam insulation](#)

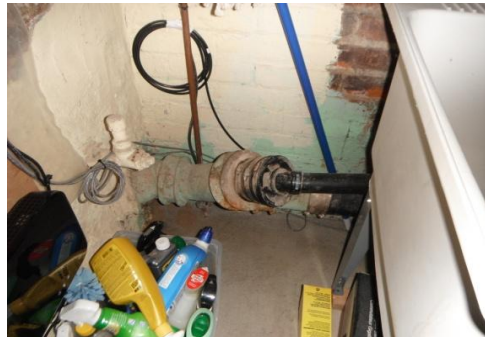
Basement Floor Drain: none found, note: main waste drain is above basement floor therefore will require drain with sump pump to discharge up into main waste drain

PLUMBING Overall good water pressure with copper and plastic supply piping. The washrooms and kitchen have recently been renovated and in good repair. Recommend installing basement floor drain - see details.
