# HOME INSPECTION REPORT

73 Laws St

Toronto

Inspection Date: Sept 9 2020

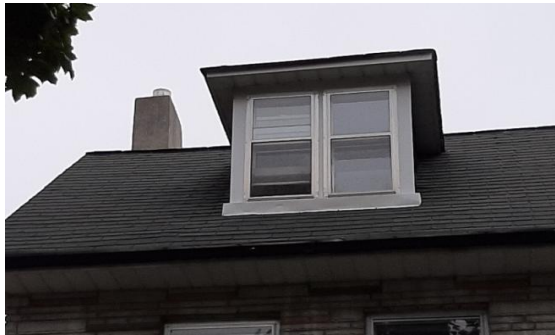
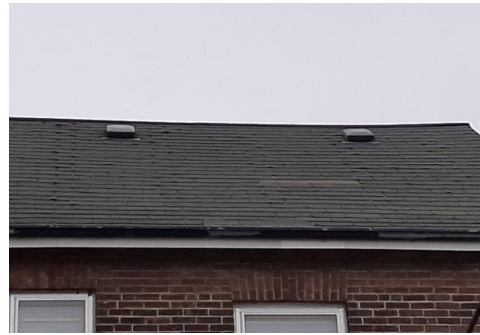
Sloped Surface: [aging surface, budget to replace within 5-yrs](#)

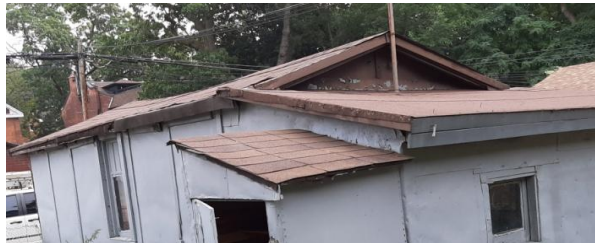
Garage: [low quality installations though overall surfaces in good condition](#)

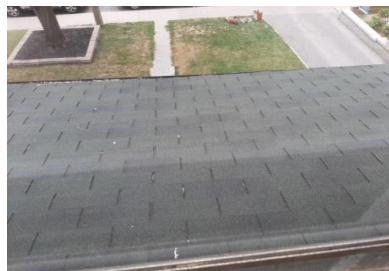
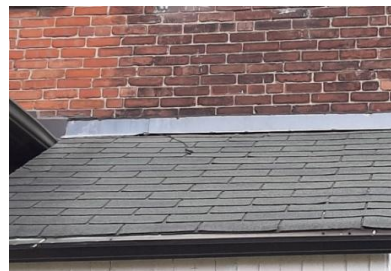
Porch(s): [aging surface, budget to replace within 5-yrs](#)  
2nd Slope: [aging surface, budget to replace within 5-yrs](#)

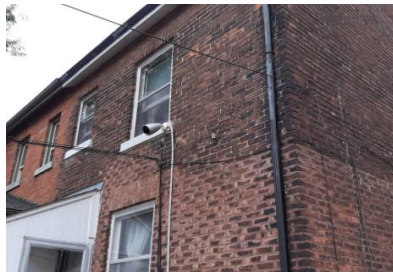
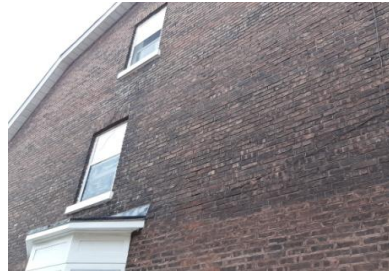
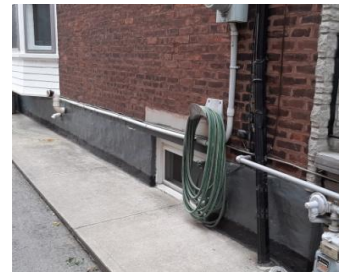
**\*\*Gutters/Downspouts:** requires general repairs and maintenance  
extend 6-ft away from house

Soffit & Facia: requires maintenance

**DOORS/WINDOWS:** older, continue to service and budget to upgrade

**\*\*Walk(s):** overall in good repair

Note: Maintain Gutters & Downspouts annually. Extend Downspouts at least 6-feet away from the house

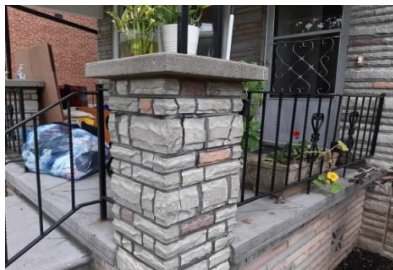
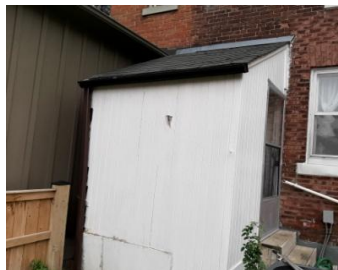
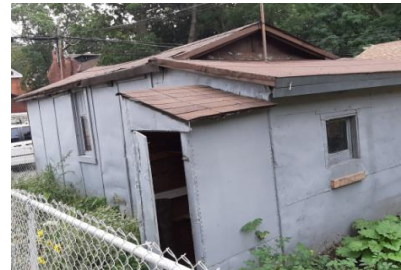
**PORCH** overall well built, columns- stone veneer requires repairs

**Comments:** rear extension requires maintenance though might consider removing as structure is suspect

**DETACHED GARAGE:** old, requires ongoing repairs or may become more cost effective to replace

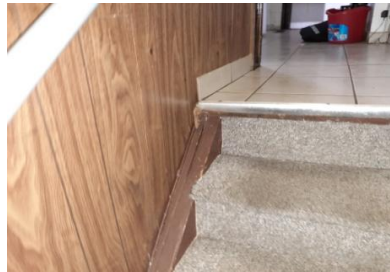
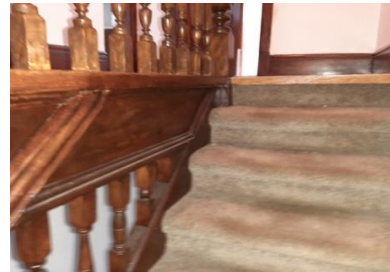
Stair Opening: typical sagging for older house

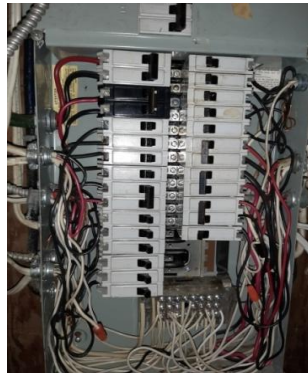
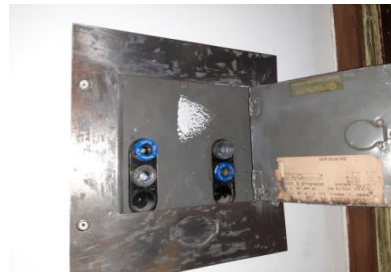
SERVICE PANEL: **overall in good repair**  
Auxiliary Panel: **replace when renovating**

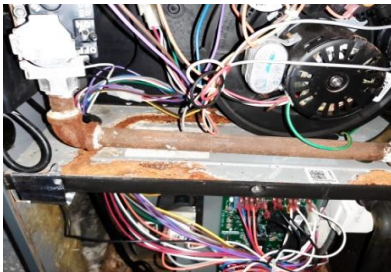
FORCED AIR FURNACE: [service annually](#)  
[rusting inside of cabinet - further evaluation when servicing,](#)  
[likely due to condensate leaking, long term leaking can reduce](#)  
[life expectancy of furnace](#)

Humidifier: [remove/replace](#)

Electronic Filter: [corroded- remove/replace](#)

Filter: [HEPA filter requires maintenance](#)

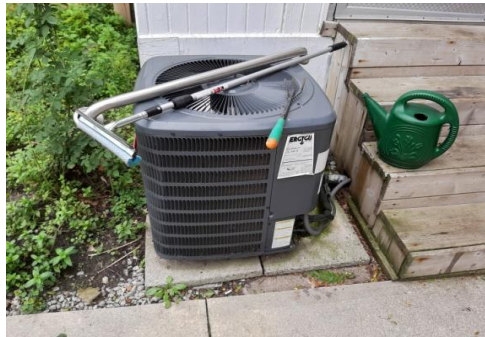
AIR CONDITIONER: [service annually](#)

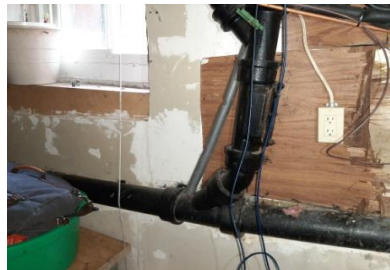
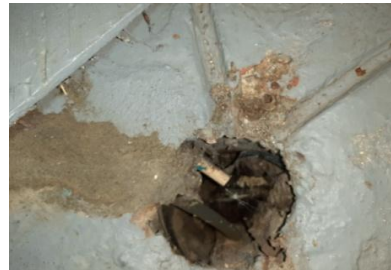
Comments: main waste drains above basement floor, install proper floor drain with waste pump when renovating, this will be required if intent is to install a basement washroom

Basement Floor Drain: these are not connected to main drain - drain into ground- see above
