HOME INSPECTION REPORT

8 Kennedy Ave

Toronto

Inspection Date: Jan 17 2019

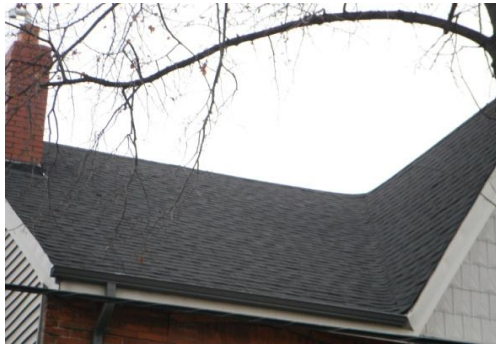
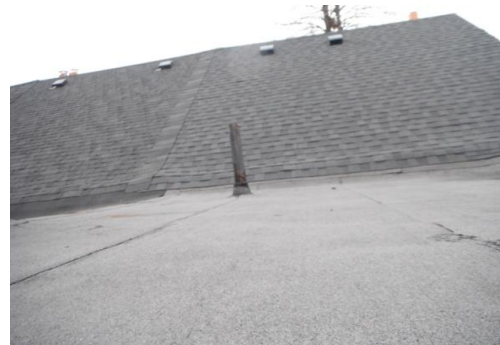
Sloped Surface: newer surface in good repair

Flat Surface: newer surface in good repair

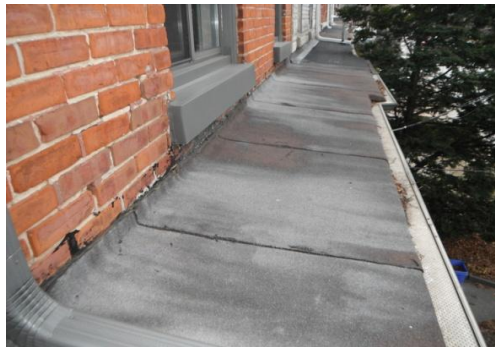
Bay(s): overall surface in good repair, recommend installing flashing along wall edge

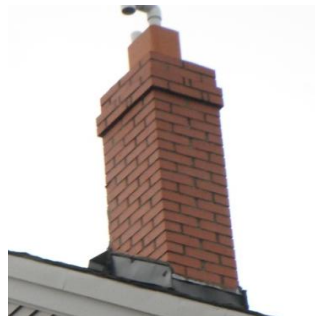
Chimney(s): rebuilt and in good repair

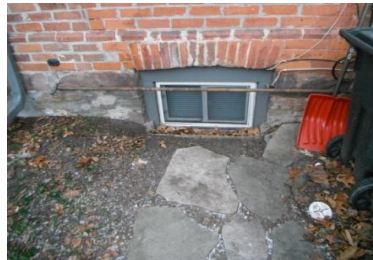
****Window Well:** at front: recommend window well cover and re-grade away from well

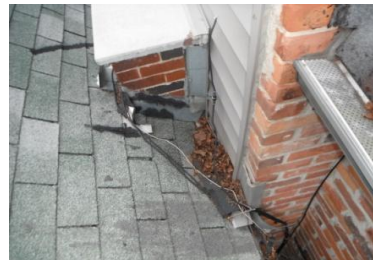
Comments: southeast corner: neighbour roof slopes towards wall, keep area free and clear of debris

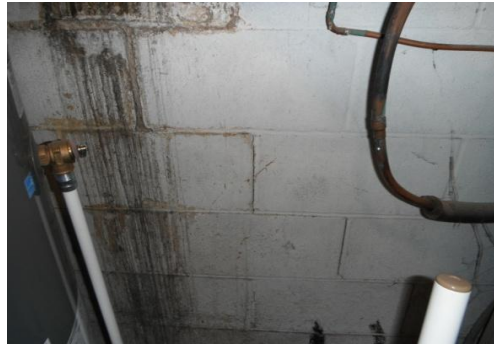
FOUNDATIONS: typical settlement crack in furnace roof area - overall minor

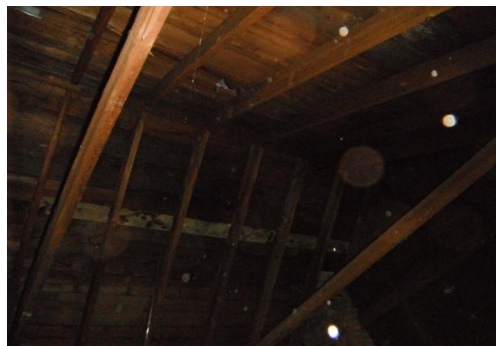
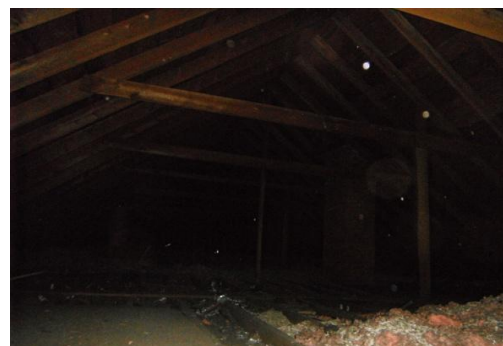
Party Walls: none in roof space between north neighbour: recommend installing to improve fire safety

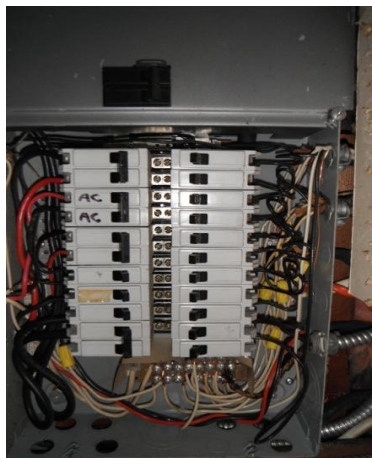
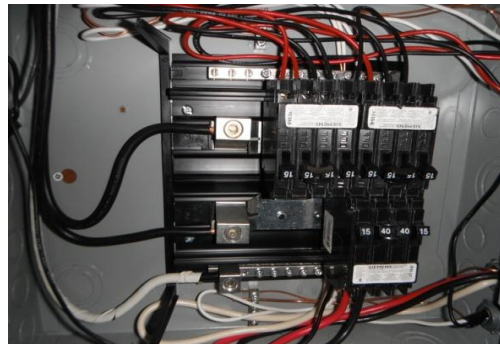
SERVICE PANEL: overall in good repair

Auxiliary Panel: overall in good repair

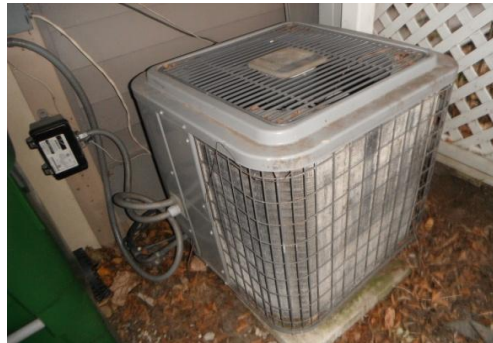
Outdoor Coil: corroded fins though typical for older unit, performance concern

AIR CONDITIONER: old unit, continue servicing until replacement becomes necessary

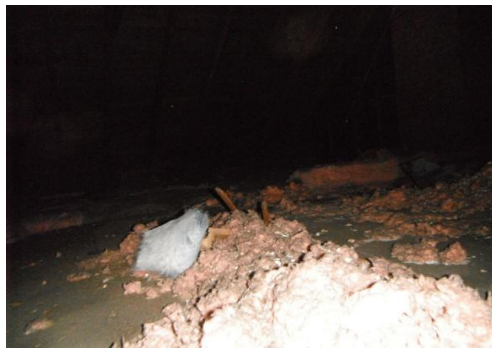
Vermiculite Insulation: [observed in addition to fiberglass and cellulose insulation, laboratory tested negative for asbestos](#)
