HOME INSPECTION REPORT

45 Morningside Ave

Prepared by: Bob Papadopoulos P.Eng., RHI *

Inspection Date: March 5 2020

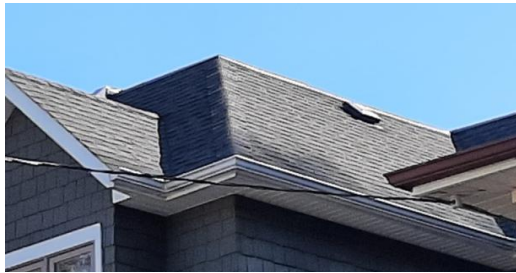
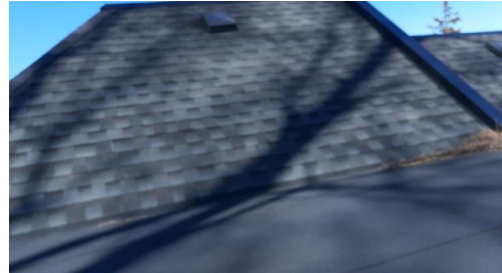
Sloped Surface: [overall surface in good repair](#)

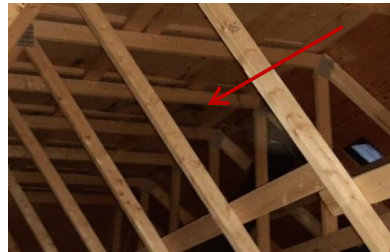
Main Flat: [not accessible, minor staining observed form underside of roof space-recommend maintenance service](#)

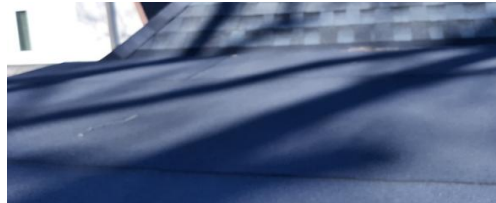
Lower Flat: [overall in good repair](#)

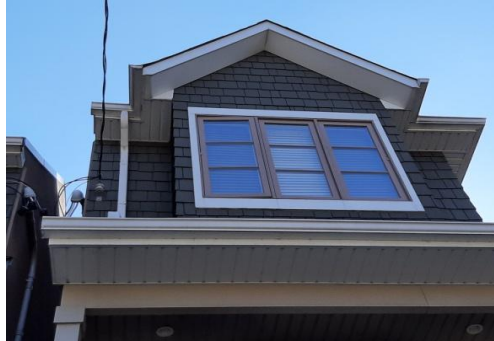
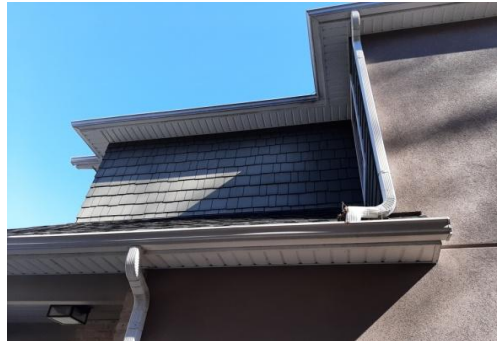
WALL SURFACES: overall in good repair

DOORS/WINDOWS: overall in good repair

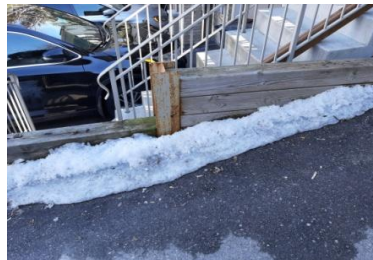
RETAINING WALL: overall in good repair

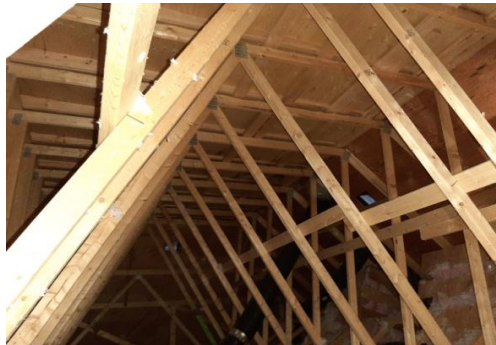
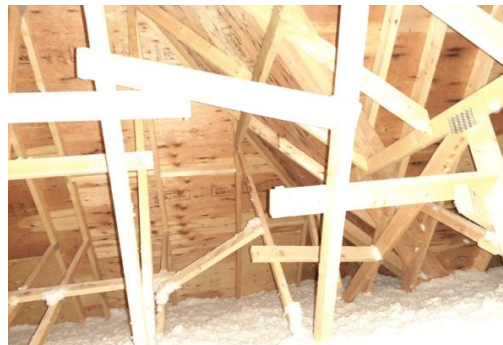
ROOF: overall in good repair

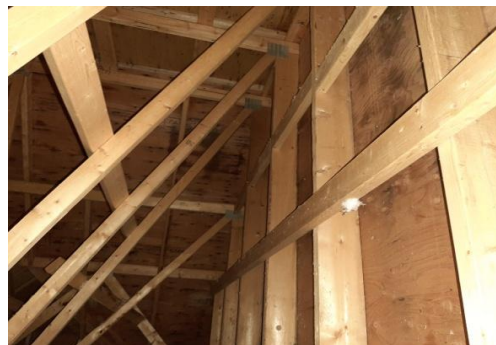
minor staining at underside of sheathing at front and east

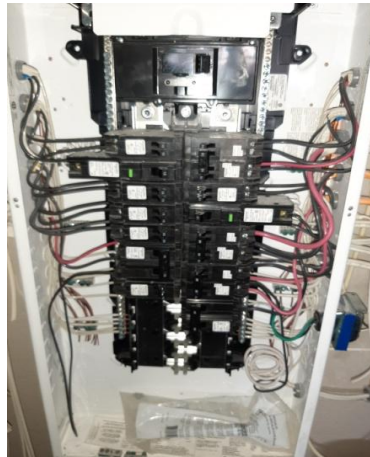
SERVICE PANEL: overall in good repair

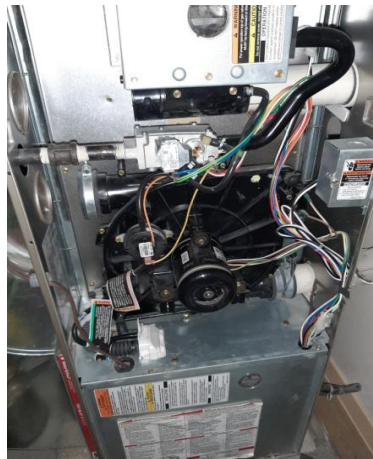
FORCED AIR FURNACE: [service annually](#)

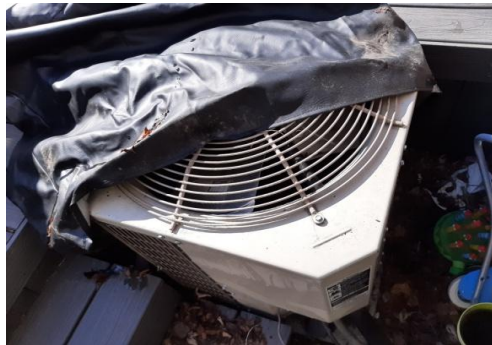
AIR CONDITIONER: [not tested: should be serviced before using service annually](#)

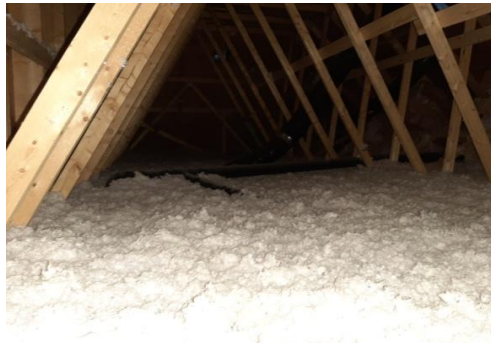
ROOF SPACE: insulation and ventilation is adequate

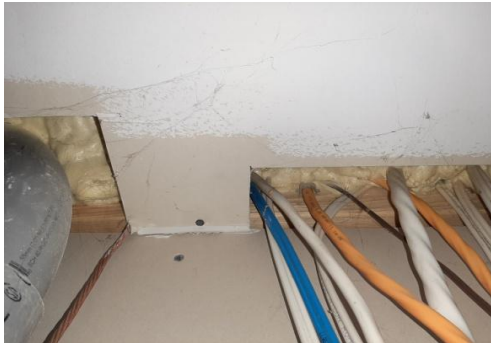
FLOORS: above garage: spray foam observed which improves comfort in room above

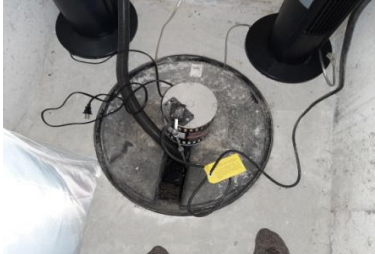
March 5 2020	
Description				
Floor Finishes: Wood Ceramic Tile	Wall Finishes: Drywall	Ceiling Finishes: Drywall	Windows: Double Glazing Casement Skylight(s) Fixed	Exterior Doors: Metal Sliding Glass
Fireplaces: Zero Clearance	Fireplace Fuel: Gas			
Limitations				
Restricted/No Access To: _____ CO Detectors, Security Systems, Central Vacuum, Chimney Flues Not Inspected Storage/Furnishings in Some Areas Limited Inspection			Foundation Not Visible <u>99</u> % Drainage Tile Not Visible	
Ref#*	Observations/Recommendations			
<p>Floors/Walls/Ceilings: overall in good repair Trim/Cabinets/Counters: overall in good repair</p> <p>Windows/Doors: overall in good repair</p> <p>FIREPLACE: service annually</p> <p>**Basement Leakage: presently no leaking detected with moisture meter random sampling the basement has been damp-proofed which will minimize moisture</p> <p>service sump pump annually- recommend back up battery</p>
