HOME INSPECTION REPORT

57 Vernon St

Toronto

Inspection Date: Oct 13 2020

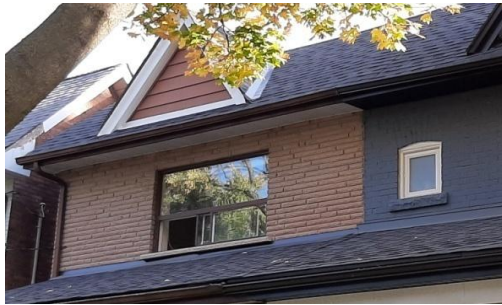
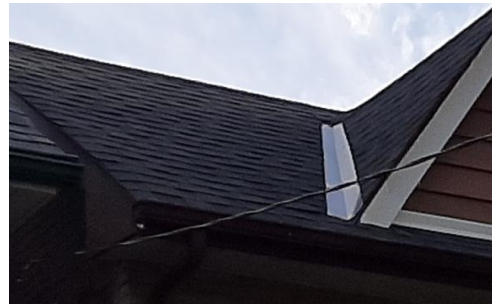
Sloped Surface: [overall surface in good repair](#)

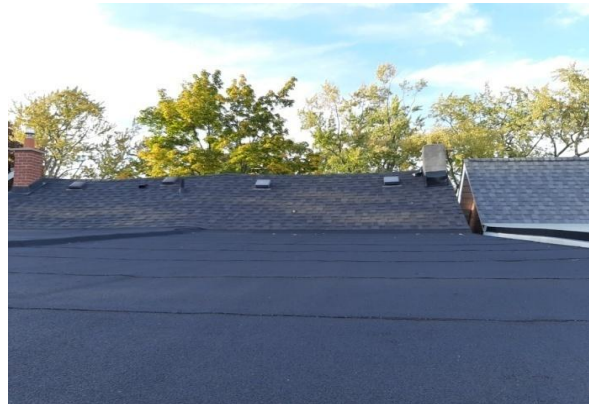
Flat Surface: [overall surface in good repair](#)

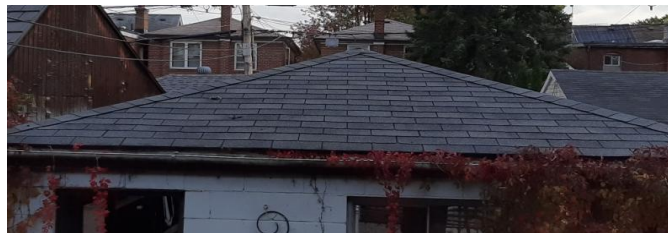
Garage: [overall surface in good repair](#)

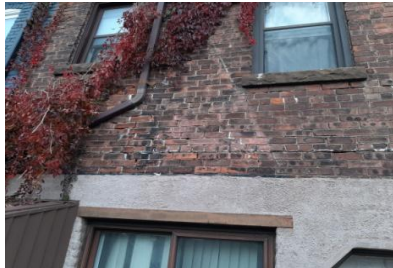
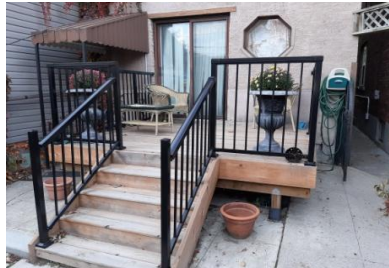
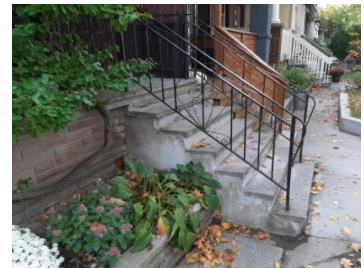
PORCH overall in good repair, step settlement: monitor and budget to replace

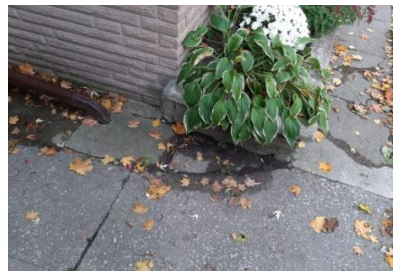
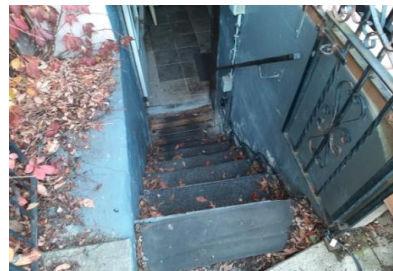
****Walk(s):** requires general repairs and maintenance

****BASEMENT WALKOUT:** drain maintenance at bottom of landing

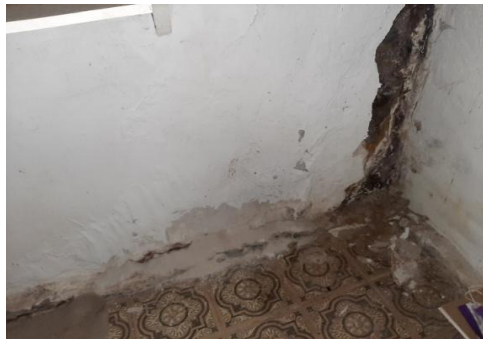
FOUNDATIONS: basement front: loose parging is cosmetic - remove loose, repair foundation mortar when renovating as required

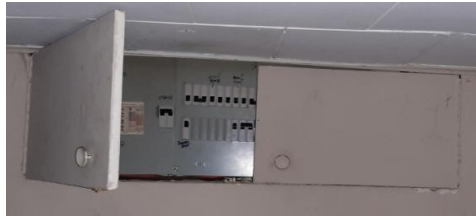
SERVICE PANEL: could not access panel due to storage and cabinet

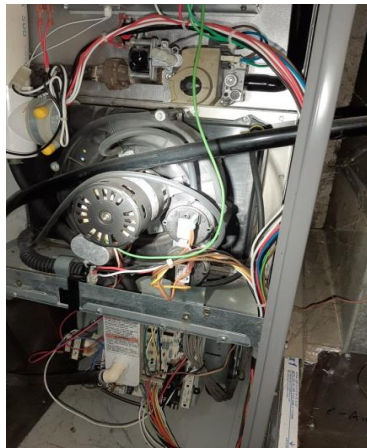
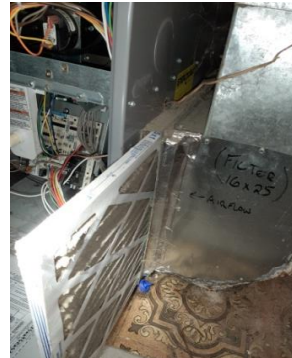
FORCED AIR FURNACE: [requires servicing](#)
Filter: [replace](#)
