HOME INSPECTION REPORT

577 Beresford Ave

Toronto

Inspection Date: March 9 2020

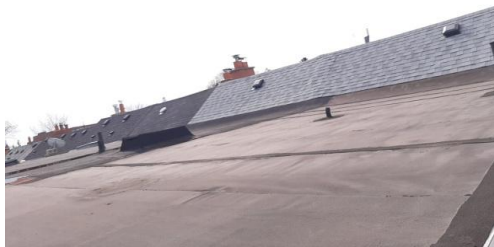
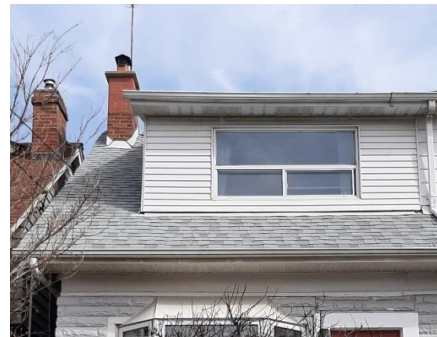
Sloped Surface: [high quality shingles overall in good repair](#)

Flat Surface: [overall surface in good repair](#)

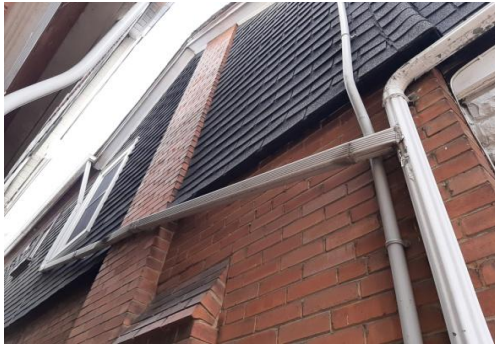
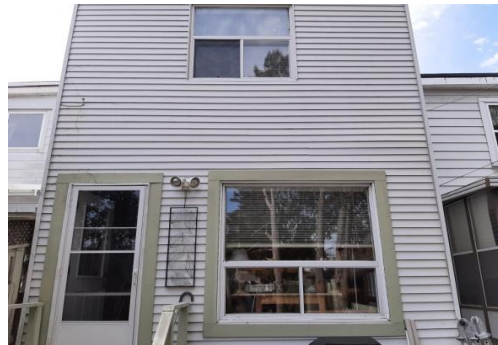
WALL SURFACES: overall in good repair
 DOORS/WINDOWS: overall in good repair

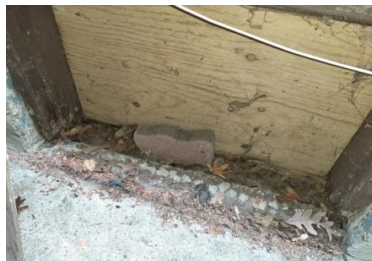
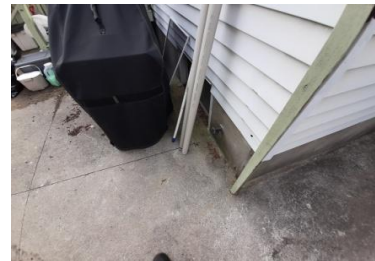
**Walk(s): overall in good repair
 basement windows- low to grade - provide threshold and seal
 abandoned unit

Note: Maintain Gutters & Downspouts annually. Extend Downspouts at least 6-feet away from the house

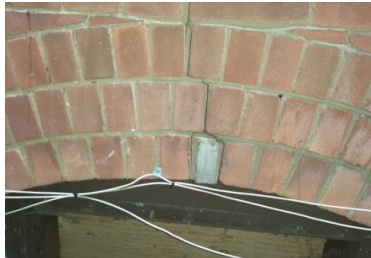
WALLS:
Masonry Arch: central basement window - minor typical crack

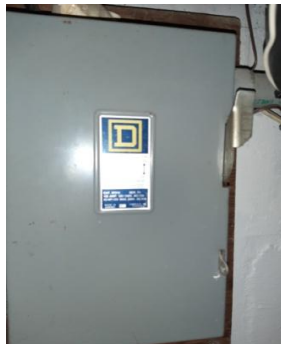
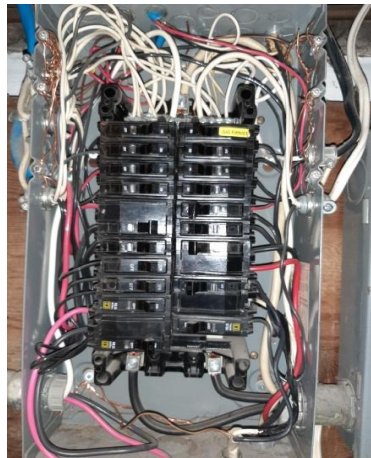
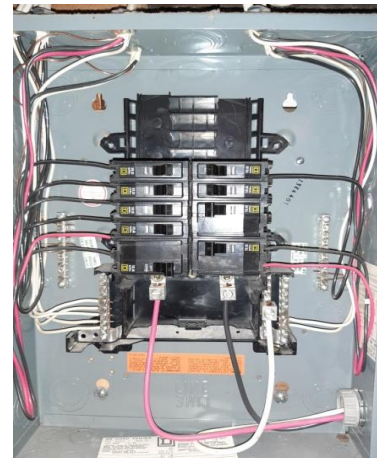
Main Disconnect: **fuse box - could not verify fuse sizes**
 SERVICE PANEL: **overall in good repair**
 Auxiliary Panel: **overall in good repair**

Note 2: Please ensure accurate labeling on panels.

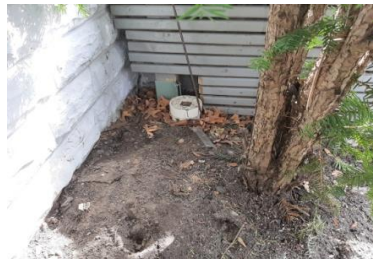
Piping: **new plastic cleanout pipe(s) at front yard indicates drain upgrades**
